CRACK SURVEY, CRACK REPAIR METHODOLOGY AND OVERLAY DESIGN FOR REHABILITATION OF A RUNWAY PAVEMENT

Abstract: Extensive cracking on the runway slabs at the Zia International Airport, Dhaka took place due to overloading of aircraft operations and poor subgrade stability. A visual crack survey was carried out in 1993. The survey detected cracks of width of less than 6.4 mm to more than 50 mm which were classified into four types according to their width of opening. Repair methodologies were developed for each category of crack. The thickness of the asphalt overlay at the centreline of the runway was 200 mm and a slope of 1.5 per cent of the surface was provided. The repair works and the construction of the overlay were carried out at night. The runway has been in service and no sign of distress has been observed since the completion of repair works and overlay construction in 1996.

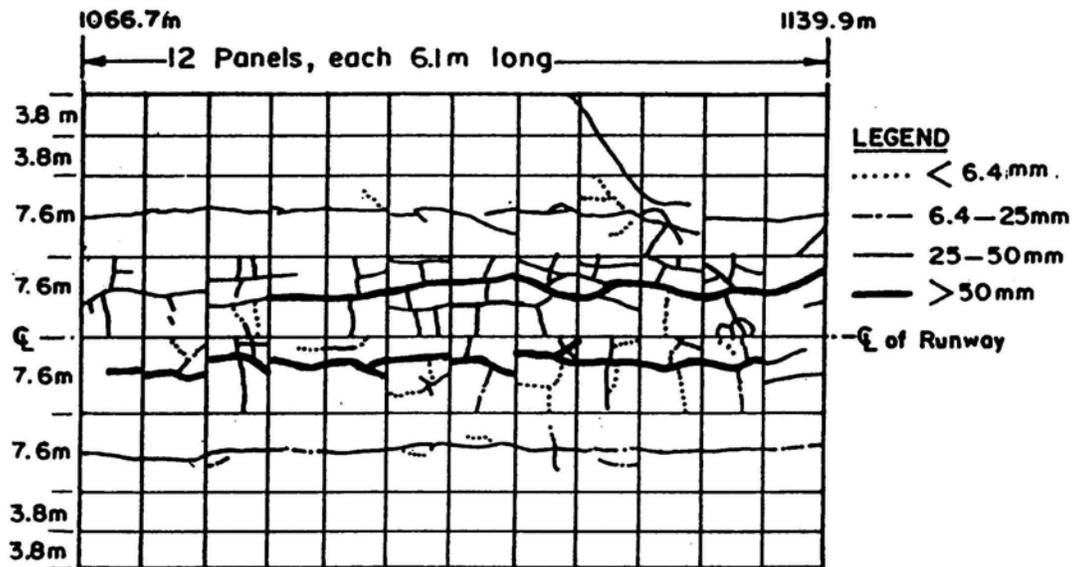
Available reports indicated that the extent of cracks increased over the last few years. Present survey shows that most of the central slabs (middle 15.2 m) are badly cracked and broken into

a number of pieces (six pieces or more). In the touch down and take-off areas on both sides (152.4 m to 518.2 m in the North end and 2438.4 m to 2895.6 m in the South end) the central slabs are severely cracked. Fig. 2 shows a typical results of crack survey for 12 panels, each 20 ft (6.1 m) in length, of the runway slabs from 3500 ft to 3740 ft (1066.7 m to 1139.9 m). It can be seen from Fig. 2 that the central slabs are severely cracked while the half-width edge slabs, which do not experience aircraft loads are, in general, in a much better condition, showing no sign of cracks.

Figure 2. A Typical Portion of Runway Slabs Showing Extent of Cracks of Varying Widths

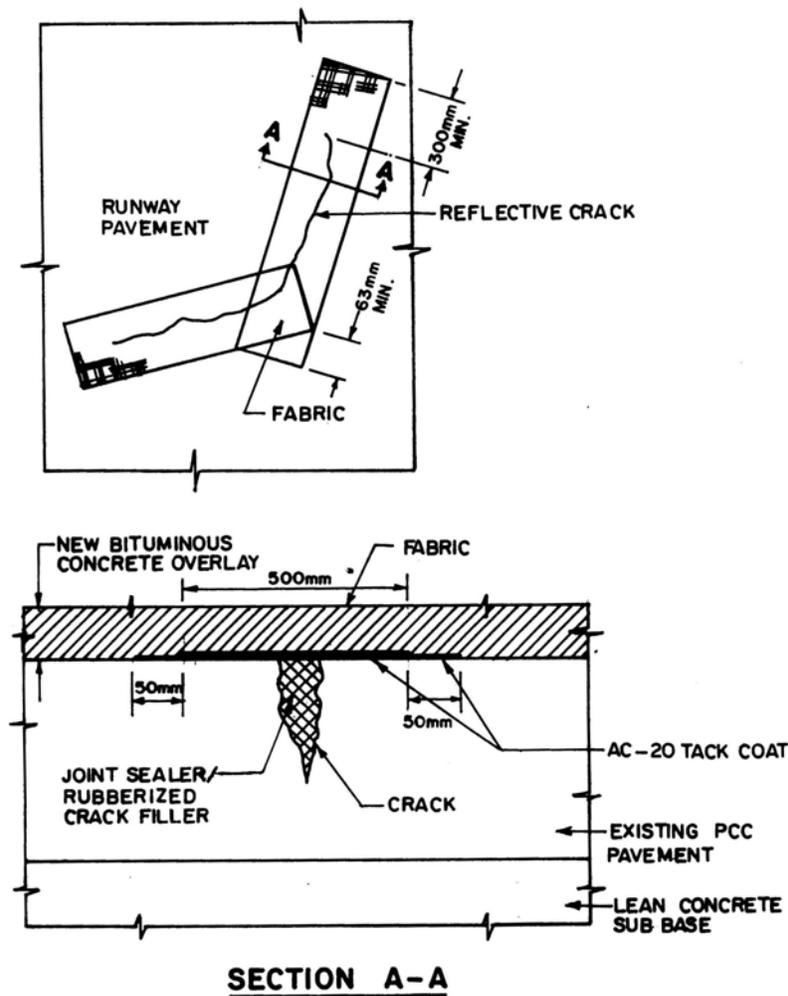
Figure 3. Typical Repair Method of Cracks of Width 6.4 mm to 25 mm and Placement Details of Fabric

- (iv) A tack coat of hot AC-20 was then applied followed by placement of a 500 mm wide high-density stress relief fabric, namely, PavePrep. Typical crack repair and placement detail of fabric is shown in Fig. 3.

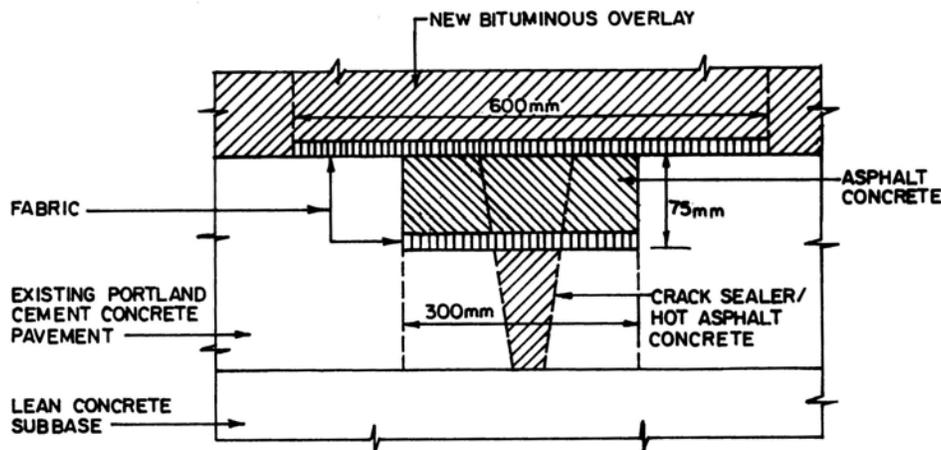
Type 1: These are single non-interconnected cracks which are relatively straight and where cutting of grooves can be done without causing damage/disturbance in the areas adjoining the

cracks are included in this type. These cracks are predominant in the slab panels between 25 ft (7.6 m) and 50 ft (15.2 m) on either side of the centreline of the runway. It was estimated that about 30% of the cracks of this width in the central slab panels (between 0 and 25 ft on either side of runway centreline) would also be in this category. Total cracks of this type were about 20000 rft (6096 m). Cracks of this type was repaired using the following procedure:

Figure 4. Repair of Wide Cracks (more than 25 mm in width) of Type 1

- (i) The area was marked taking at least 25 mm from the edge of the cracks.
- (ii) Trenches of 300 mm wide and 75 mm deep was formed, as shown in Fig. 4, using concrete cutting wheel/machine.

- (v) Cracks / cavity at the bottom of the trench, if present, was filled up using either a liquid sealer (as in case of cracks of width 6.4 mm to 25 mm) or a hot-mix asphalt similar to that used for the surface course (for large cracks and cavities). A hand tamper was used to compact the hot-mix asphalt in the bottom of the trench.

- (x) A tack coat of hot AC-20 was applied on the trench area and another layer of *PavePrep* similar to that used at the bottom of the trench but of width of 600 mm was placed.

- (xi) Hot-mix asphalt overlay was placed following the placement at the second layer of *PavePrep*. Prior to hot-mix overlay, the top of the *PavePrep* was tacked over along with the existing surface at a rate determined by trials.

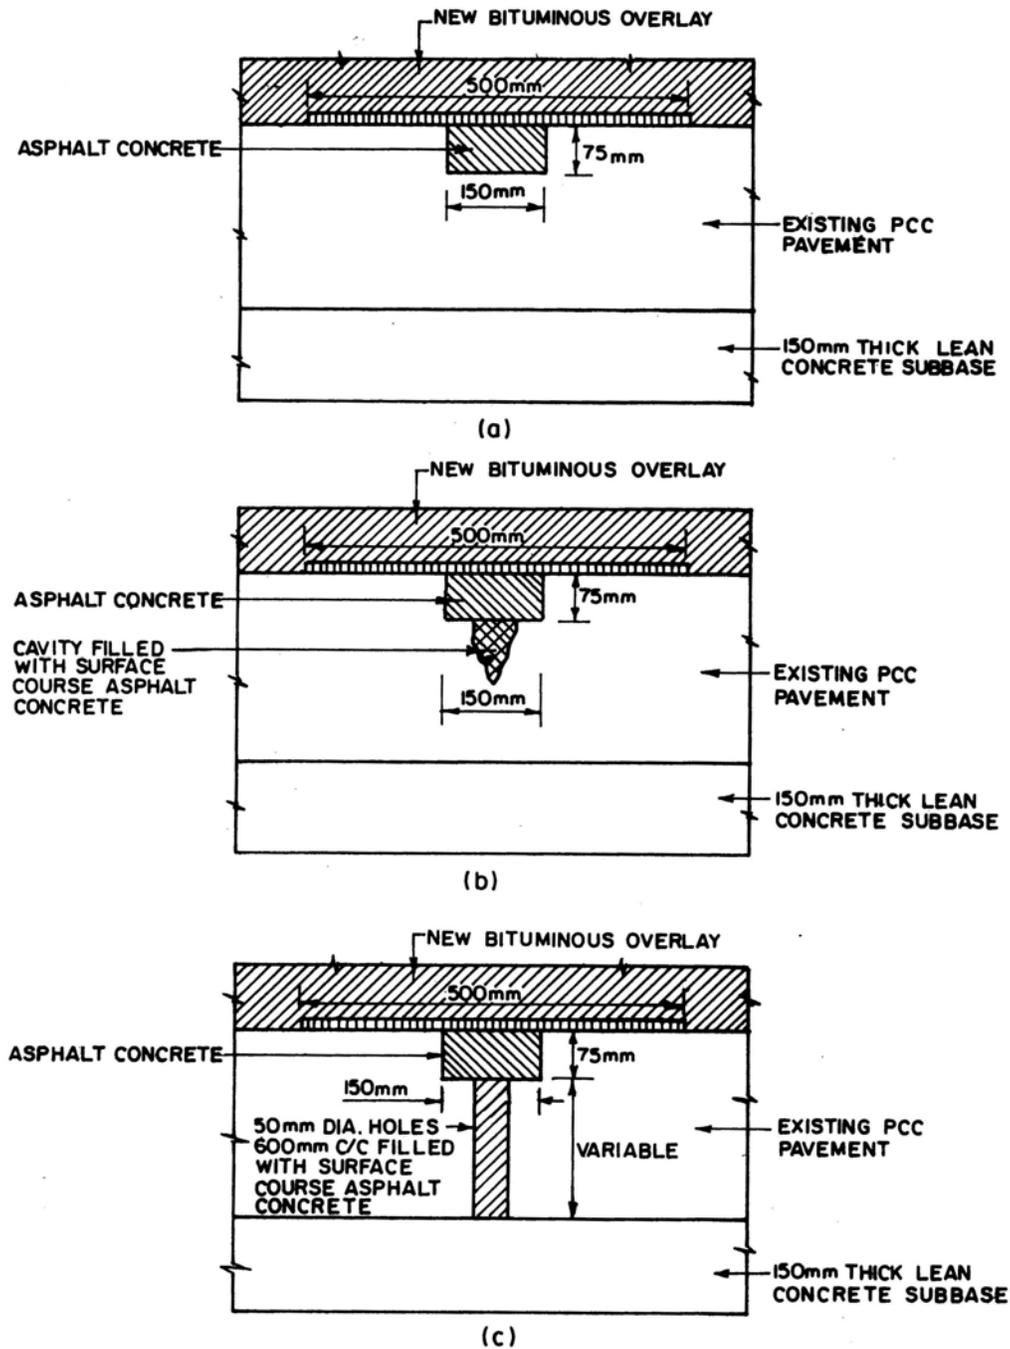
Type 2: Large cracks for which 150 mm wide and 75 mm deep trenches were cut and filled with asphalt concrete previously by the CAAB (about 9200 rft, i.e., 2804 m) are included in this type. The following procedure was adopted for repairing for this type of cracks.

Figure 5. Repair of Wide Cracks (more than 25 mm in Width) of Type 2

- (a) Where 300 mm wide trenches may be cut without damaging the adjacent areas, the procedure and materials specified for the repair of Type 1 cracks were used.
- (b) Where trench cutting similar to that for Type 1 was not possible without damaging the concrete in the adjoining area, the following steps were adopted for repair of these cracks:

- (iii) All loose materials and debris were removed from the trench using sweepers with vacuum hose attachment.
- (iv) If no crack/cavity was found at the bottom of the trench, the trench was filled up with asphalt concrete [Fig. 5(a)]. Tack coat of hot AC-20 was uniformly applied on the edges and the bottom of the trench before placement of the hot-mix asphalt. The mix was compacted using vibratory rollers. The level of compacted asphalt was the same as the adjacent PCC slab. If on completion of step (iii) of this method, a large cavity was found at the bottom of the trench, it was filled up with a surface course of hot-mix asphalt and compacted to the level of the bottom of the trench. The mixture was tamped appropriately in place [Fig. 5(b)]. Tack coat of hot AC-20 was uniformly applied on the vertical edge and bottom of the trench and the trench was filled with hot-mix asphalt and compacted to the level of the PCC slab. If, however, on completion of step 3 of this method, cracks were found at the bottom of the trench, 50 mm diameter holes were drilled along the crack 600 mm centres up to the bottom of the slab. Using an air compressor with hose and nozzle attachment, the dust from the holes was blown out. An asphalt (AC-40) meeting the requirements of ASTM D3381 (ASTM, 1986) was heated to a safe temperature to make it sufficiently fluid suitable for pumping through the holes using a pressure distributor at a pressure of 175 kPa to 415 kPa until the cracks up to the bottom of the trench were filled up. Requirements of AC-40 is shown in Table 2. Temporary round wooden plugs were used. After the asphalt had hardened, the temporary plugs were removed and the holes were filled with an asphalt surface course mixture, thoroughly tamped in place. Tack coat of hot AC-20 was uniformly applied on the vertical edge and bottom of the trench and the trench was filled with hot-mix asphalt and compacted to the level of the PCC slab.

- (vi) Hot mix asphalt overlay was then placed after an uniform application of tack coat of hot AC-20 on the PavePrep and the existing surface as mentioned in step (xi) for Type 1 cracks.

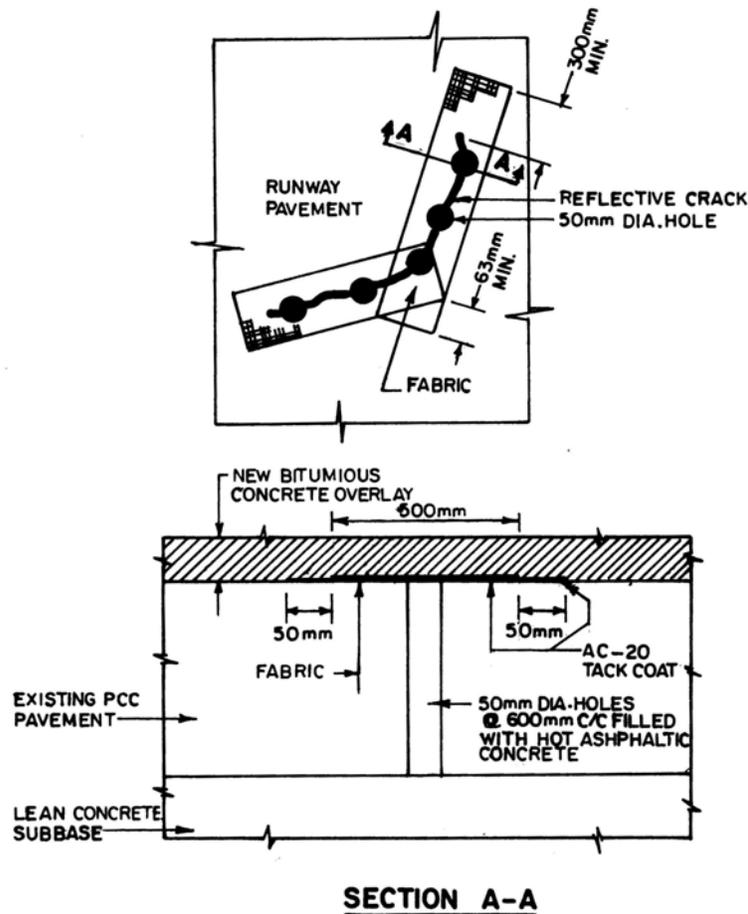
Type 3 : Crack survey revealed the presence of many random and interconnected wide cracks where trench cutting similar to that for Type 1 cracks would not be feasible and any attempt to groove cutting is likely to cause serious damage to the runway slab. About 20,000 rft (6096 m) of cracks of this type were identified. These cracks were repaired using the following method:

Figure 6. Repair of Wide Cracks (more than 25 mm in Width) of Type 3

- (i) 50 mm diameter holes were drilled through the entire slab on 600 mm centres along the crack.
- (ii) Debris from the holes was removed and using compressed air. The holes were cleaned from dust, any loose and foreign materials.
- (iii) The cracks and holes were filled up using materials as mentioned in step (iv) for Type 2 cracks.
- (iv) Tack coat of hot AC-20 was then uniformly applied and high-density fabric PavePrep of width 500 mm was placed following standard procedures as shown in Fig. 6.
- (v) Tack coat of hot AC-20 was uniformly applied on the top of the fabric and the existing surface before placement of the hot-mix asphalt overlay.
- (vi) The top of the fabric and the existing surface was tack coated before placement of the overlay.

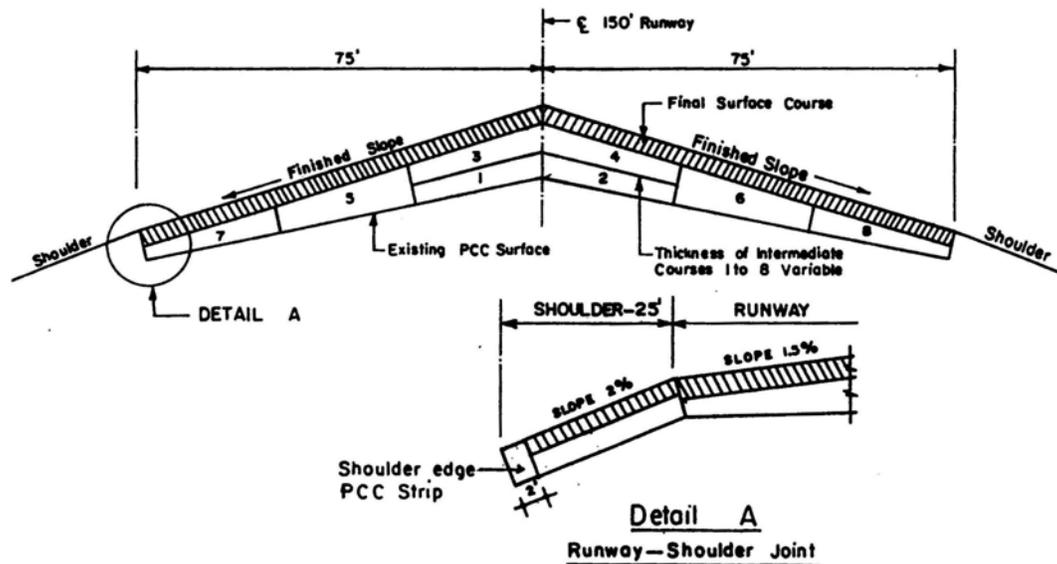
Figure 7. Typical Overlay Section Showing Sequences of Lane Placing Using 25 ft (7.6 m) Wide Paver

Information on aircraft operation indicated that the wide-bodied aircraft DC 10-30/40 is the critical aircraft for overlay design. The overlay has been designed for an estimated annual departure of 12000 of the design aircraft having a gross load of 550000 lbs. However, the design was verified for annual departures of 6000 and 15000 for the design aircraft as well as other heavy aircraft such as 747-200 (gross load = 800000 pounds) and L1011-200. The airport pavement overlay design method contained in Aerodrome Design Manual published by International Civil Aviation Organization, ICAO (1983) was followed. A flexible overlay of thickness of 8 inch (200 mm) at the centreline was provided. This overlay ensures a PCN of the resultant runway pavement in excess of 59 as specified by the CAAB. A 600 mm wide and 150 mm thick strip of cement concrete was provided on either edges of the shoulder to provide protection from the encroachment of vegetation and ensure lateral support to the shoulder. In order to improve drainage, slopes of 1.5 per cent for the overlay surface of the runway and 2 per cent for the shoulder were provided. Taking into consideration of slope of the existing slab (1 per cent), 3.5 inch (89 mm) thick overlay at the edge was provided. The

thickness of the overlay on the shoulder was uniform and was equal to 3.5 inch (89 mm). Typical section of the overlay showing sequences of lane placing based on the use of 25 ft (7.6 m) wide paver is shown in Fig.7. A surface course of uniform thickness of 2 inch (50 mm) across the entire width was provided. The thickness of intermediate layer(s) varied with the depth, which reduced towards the edge. The shoulder was constructed in two layers. The thickness of the surface course was reduced to 1.5 inch (38 mm) for the shoulder. The entire construction of the hot-mix asphalt overlay was carried out at night and construction of the overlay was completed in mid 1996.
