Pavement Distress Evaluation Using Pavement Condition Index around Agora Market, Barangay Lapasan, Cagayan de Oro City

Risa Gwen J. MARTINEZ^a, Anabel A. ABUZO, D.Eng.^b

^{a,b}*Civil Engineering Department, College of Engineering, Xavier University – Ateneo de Cagayan, Cagayan de Oro City*

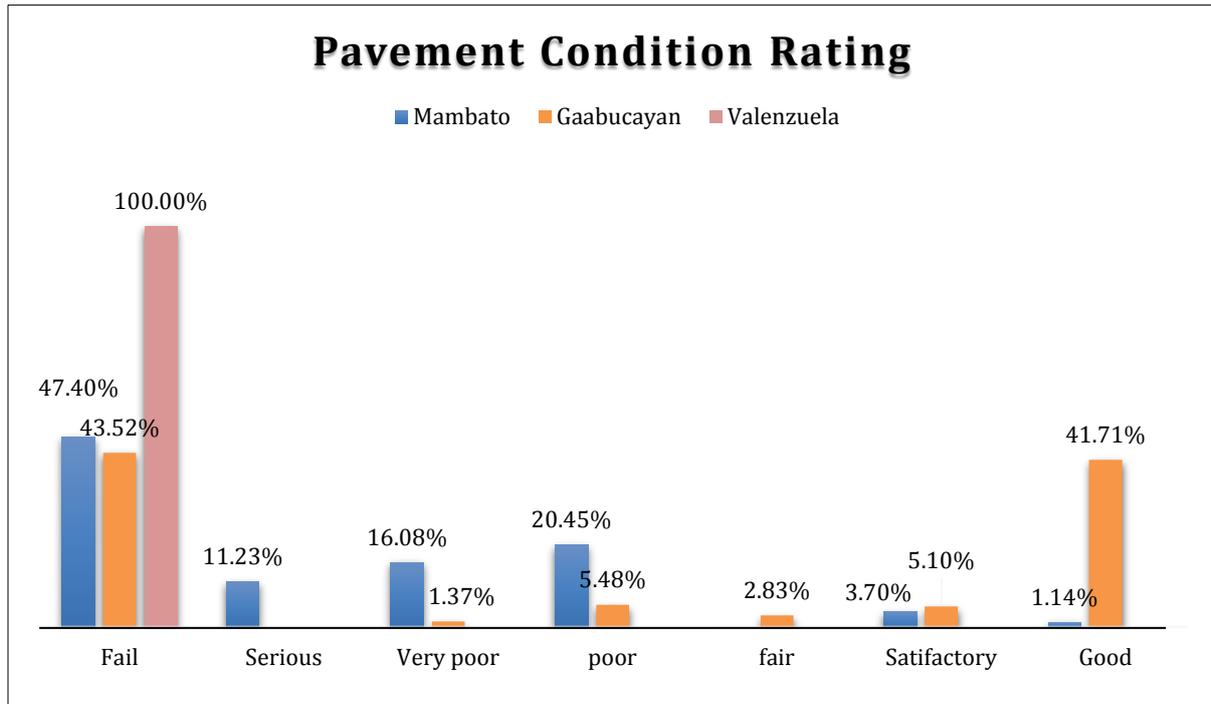
Figure 2. Pavement Condition Rating

Figure 2 shows the overall rating per street in terms of percentage. From the graph, it shows that all pavements of Valenzuela Street have the worst level of severity having 100% of entire pavement as totally distressed or is in its failed condition. On the other hand, the severity level that dominates Gaabucayan Street with 43.52% of the entire pavement is a failed condition, however, 41.71% of street is still in its good condition, 5.48% of the street is poor, 5.10% gives a satisfactory rating, 2.83% is fair, and 1.37% is very poor. Whilst in

Mambato Street, failed pavement condition dominates the entire street with 47.40% of the entire pavement is affected, 20.45% is poor, 16.08% is very poor, 11.23% is in its serious condition, 3.70% is satisfactory, and only 1.14% of the Mambato Street is good.

As shown in Figure 2, most roads around Agora Market are in their very poor, serious and failed condition. Thus, the pavements along the road would worsen the distress severity case due to daily traffic volume since loaded cargo trucks and utility vehicles are the main road users.

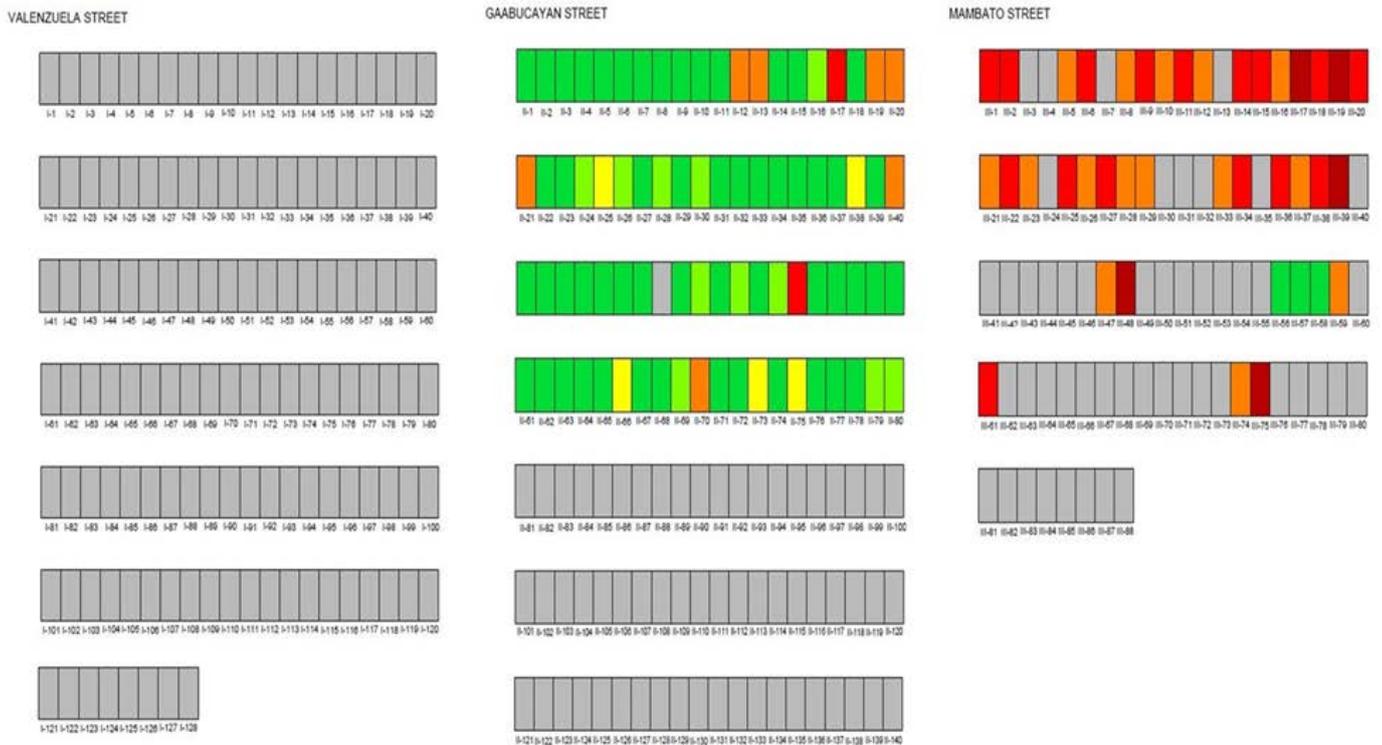
Figure 3. Straight Line Diagram

Also, shown in Figure 3 is the Straight Line Diagram (SLD) which summarizes the current situation of the pavement around Agora Market prior to the rating scale on Table 1. It is clear enough that the Valenzuela Street has the worst level of severity having 100% of the entire pavement as totally distressed or is in its “Failed” condition. Valenzuela is the main access road where almost all types of vehicles, as enumerated from the AADT, especially huge cargo or trailer trucks, enter Agora Market. Also, Mambato Street contains pavements that are in “Failed” condition due to the fact that numerous large and small buses, passenger car and passenger utility vehicles access the road. For Gaabucayan Street, the first eighty (80) pavement sections were still under “Good” condition. These sections were from the other end of the road (perpendicular to the Corrales Extension) and not around the Agora Market. The road is known as the Gaabucayan Extension. It is in its good condition because the main users of this road are motorcycles, motor-tricycles, and private vehicles which nearly do not contribute severity to the distresses since it has light to medium weight compared to large vehicles. However, the eighty-first (81st) pavement which approaches the main Gaabucayan Street (circumferential road of Agoras Market) illustrates that the pavement starts to fall under “Failed” condition because all vehicles that access Valenzuela Street will also be using or passing the Gaabucayan Street since Agora Market alone is a one way – four lanes path. Thus, buses, private and public vehicles, huge cargo and trailer trucks, worsen the condition of the road pavements.
