Planning Roadside Sign System for a Historical Park to Minimize Path Finding Errors

Abstract: Sign systems in tourist areas are expected to give correct information for the benefit of visitors who could be familiar or unfamiliar with the area. A well designed sign system can improve the visitor's circulation within the area to improve exposure of attractions and facilities there. The aim of the signs is ensure visitors can visit more attractions than before. This study investigates the sign system in Nara Park which is one of most popular tourist areas in Japan. The new sign system introduced in 2011 has visitors circulation improved, although the number of visitors getting lost visitors has not deceased. This study investigates the rate of getting lost with respect to the installed sign system.

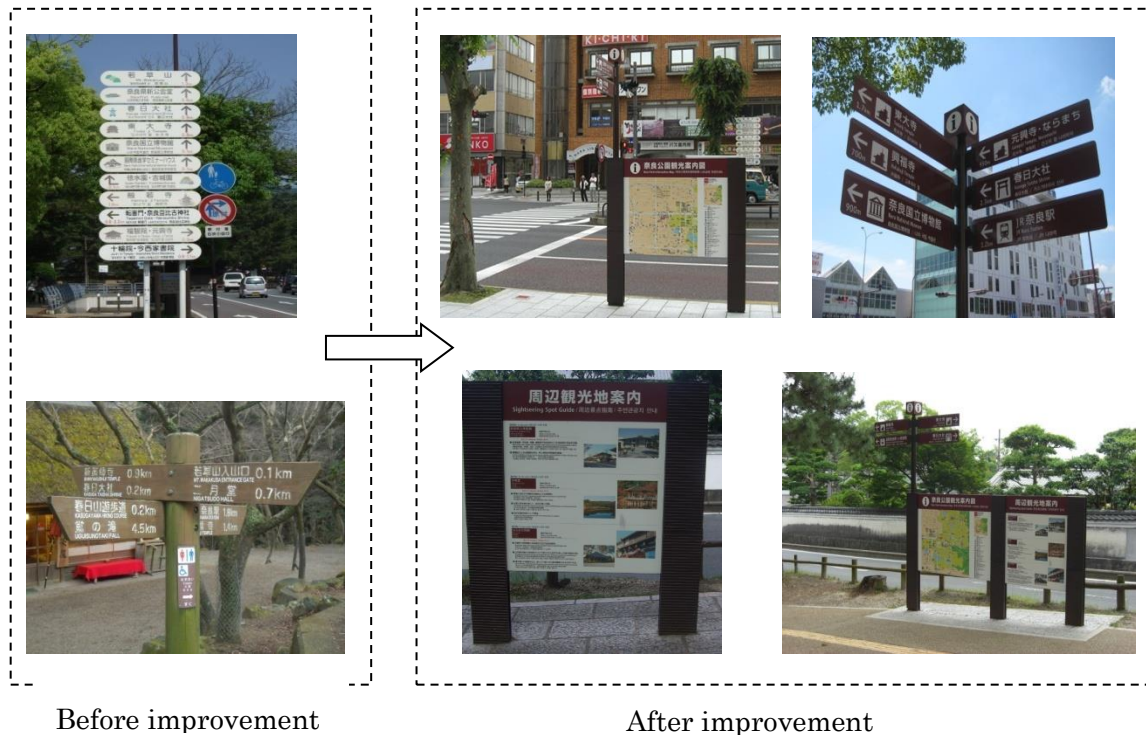
Figure 1 Signs in Nara Park before and after improvement

Signs in the area (a) and a part of the area (c) have been changed as shown in Figure 1.

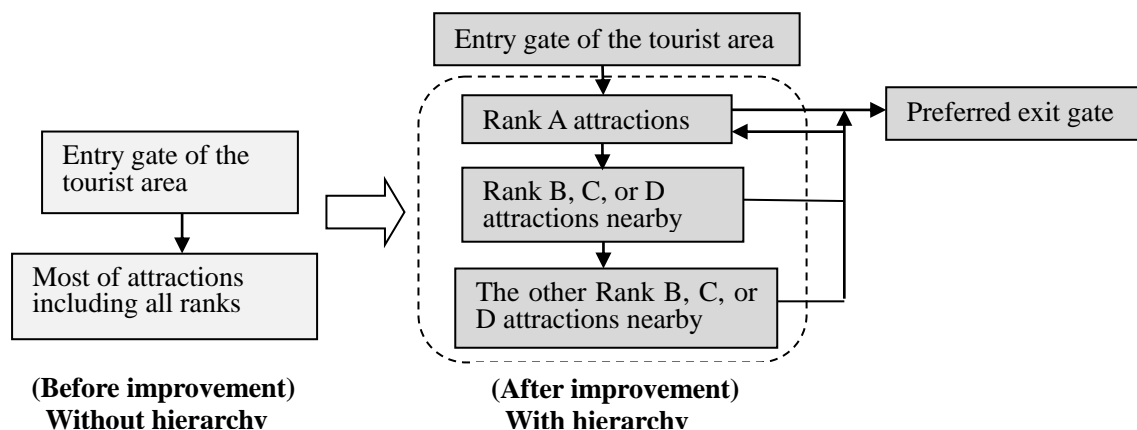
Figure 2 Concept diagram of design objective of the modified sign system

Concept plan for selection of content and style of roadside signs constructed by Nara Prefecture within the Park grounds are shown in Figure 2.

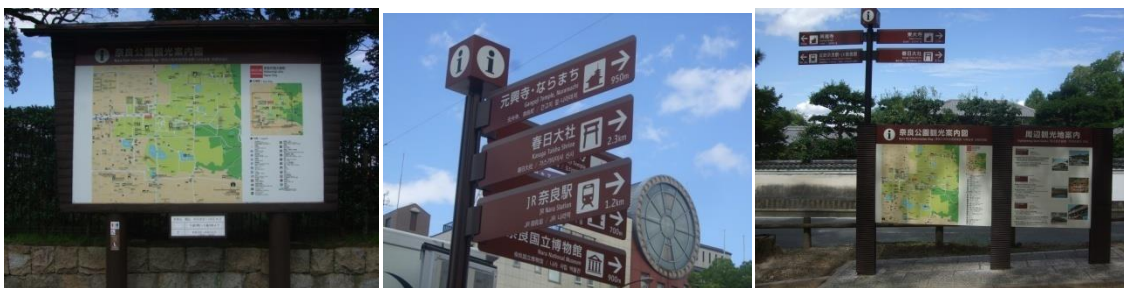
Figure 3 Examples of signs improved by Nara Prefecture

For the purpose of balancing simplicity and consistency of the prefecture constructed signs, the number of styles of signs has been limited to three. Figure 3 shows examples from each of the style categories. The first category is referred to as ‘map boards’ which focused on providing an overview of the spatial distribution. The next type is called ‘arrow signs’ which focused on providing directions to destinations and landmarks by pointing arrows (see Fig 3). A consistent icon system has been adopted to denote landmarks, destinations and services indicated on arrow signs. About 50% of signs provided by the prefecture are arrow signs. The third category is called ‘Map and Arrow signs’, indicating these locations contain a hybrid version of map boards and arrow signs. About 20% of signs provided by the prefecture belonged to this ‘map and arrow’ category (see Table 2).

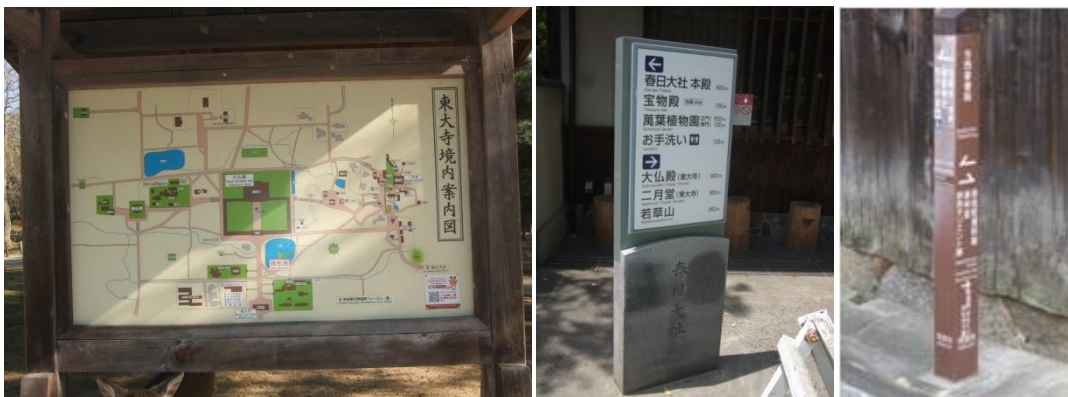
Figure 4 Examples of sign boards constructed by other organizations

On the other hand, signs constructed by Temples and Shrines, and those constructed by Nara City remained as they were in the past. Some examples are shown in Figure 4. When maps are shown as the example shown in Figure 4, they are inaccurate schematics designed for the purpose of highlighting facilities and services for the sign owners benefit. Even arrow signs maintained by temples and shrines are laid out in haphazard and unhelpful manner, making them difficult to convey the correct direction. Nara city maintains the square post type signs from a different era which are primarily of value as curiosity items pointing at sites that may have been of some importance in past. These posts in Nara-machi area require an effort from road users to decipher the content in a useful manner to find specific destinations.

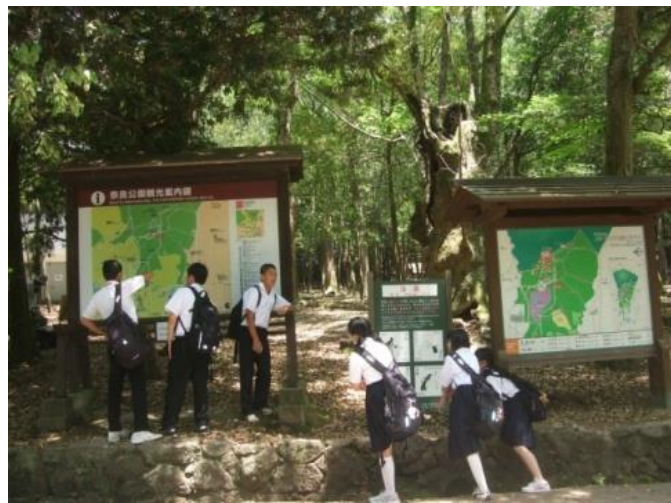
Figure 8.3 Spot (C)

At location of (C) mentioned before, there are two different types of signs, one provided by Nara Prefecture and the other constructed by Kasuga-taisha Shrine. Figure 8.3 shows school students studying these signs during an excursion to the park, because different maps with its own concept show different information in almost the same area.

- (b) There are locations where improved sign boards and older style constructed by other owners exist close to each other. An attempt must be made to minimize the occurrence of such redundancies and confusions (Fig. 8.3).

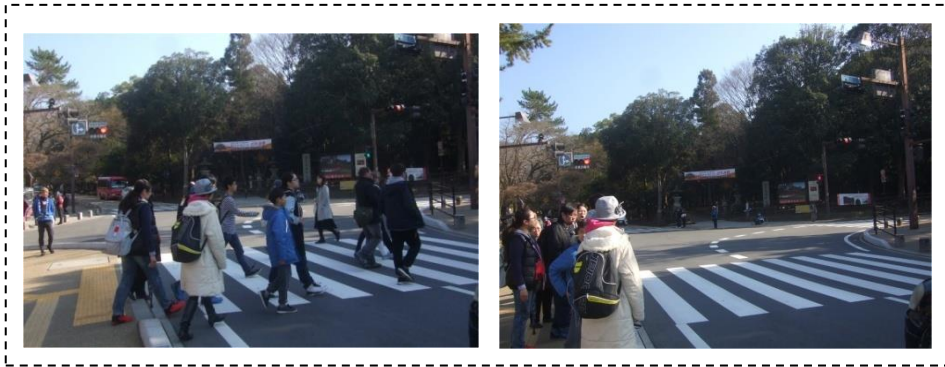
Figure 8.4 Spot (D)

Locations (D) and (E) are located at major intersections in Nara Park. Sign boards are available at these locations. However, since the intersection is large and sign boards exist only at a particular corner, some tourists seemed to be confused here to find their ways.

- (c) Frequency of getting lost events peaks at the second or third links of trip chains of park visitors (Figs. 8.11, 8.1, and 8.2).
- (d) Count of getting lost events was high at several large intersections, although at least one sign has been available in the area. These locations may need further evaluation. Additional signs maybe required to assist visitors (Figs. 8.4 and 8.5).

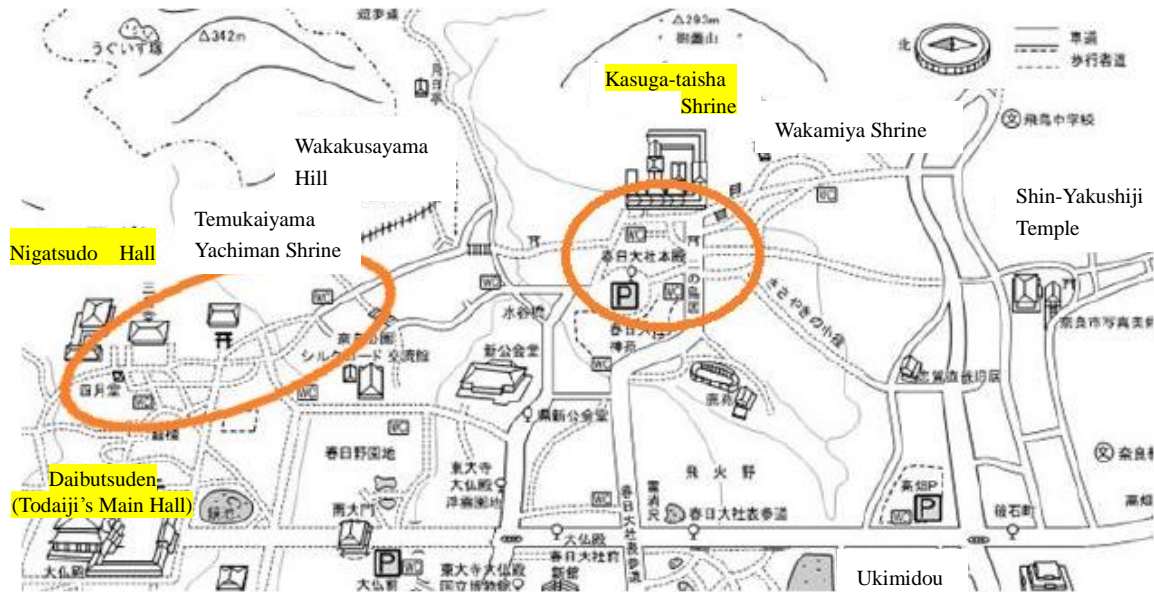
Figure 9 Locations of Interview sites

Interviews were carried out in November, 2015, at areas where the count of getting lost events were found to be high as described in a former section, to uncover the reasons for such events. There were two interview locations. First location was in Todaiji Temple area and second interview location was in Kasuga-taisha Shrine area as illustrated in Figure 9.

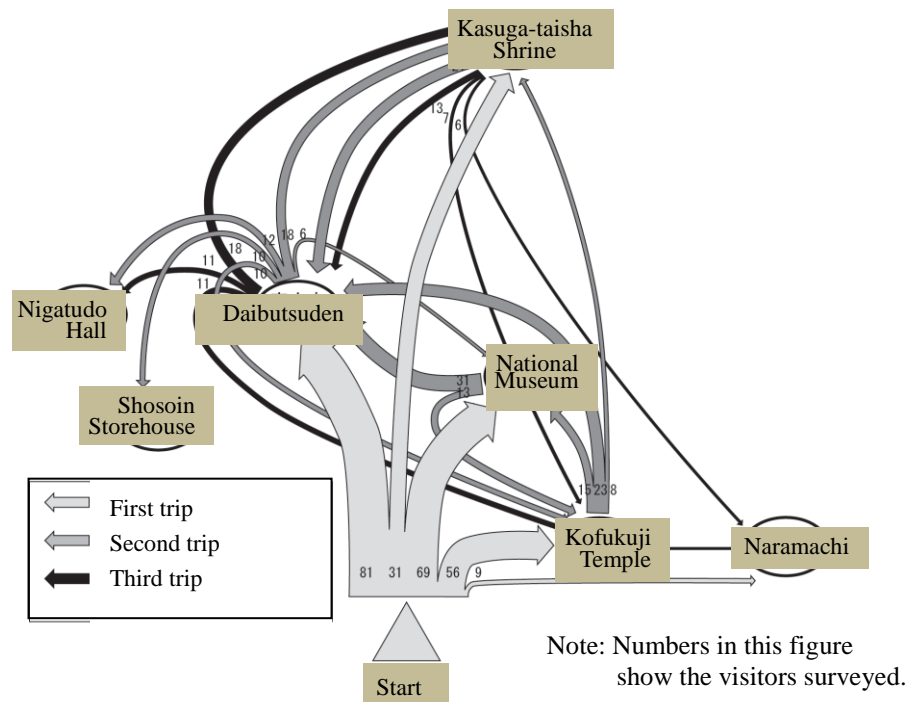
Figure 10 Trips chains of those who visited the park for the first or second time

Visitors make several trips within the historical park during the time they spend there. Figure 10 shows the pattern of first three trips visitors made according to a field survey reported in 2009. Figure 10 confirms that Todayji Temple, Kofukuji Temple, Kasuga-taisha Shrine, and Nara National Museum are major attractions and they have become the destination in the first link of the trip chain of park visitors (Tanaka et al. (2009)). Todayji Temple and Kasugataisha Shrine are large religious organizations, therefore number of historical and cultural sites spread out within their individual premises. For example, Daibutsuden, Nigatudo Hall, and Shosoin Storehouse belong to Todayji Temple.

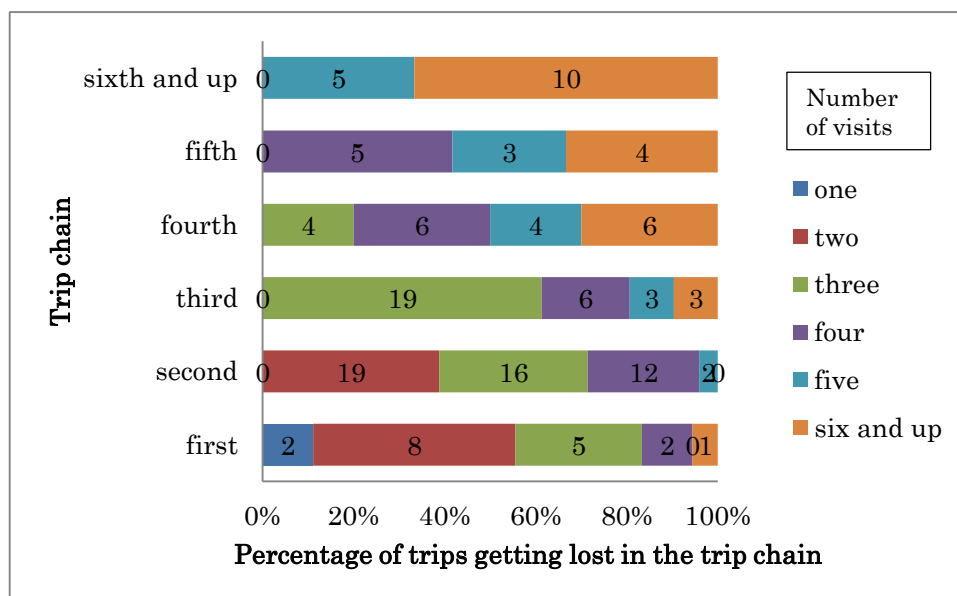
Figure 11 Getting lost behavior considering tourist's trip chain

Figure 11 illustrates the distribution of count of getting lost events in percentage terms with respect to the length of the trip chain. Figure 11 was drawn using the 140 data which were clear the relationship between getting lost events and the trip chain in the survey carried out in 2013. It is apparent that there is an upward trend in the latter half of trip chain. For example, in the case of tourist visiting six attractions and more, most got lost events occurred after the third trip.

Visitors who performed a trip chain of two links, reported a tendency to get lost in the second trip more than in the first trip of the trip chain, according to Figure 11. Visitors with three links had more difficulties encountered in the second and third than in the first link of the trip chain.

Anyhow, implications of the distribution shown in Figure 11 need further investigation.
