## **Audit-based Comparison of Safety Deficiencies at Signalized Intersections: Lessons Learnt from India and Germany**

**Abstract:** Developing countries report a higher degree of road accidents as compared to the developed countries. This paper attempts to apply a road safety audit-based approach to identify and present the distinct differences in the operation of urban signalized intersections from the perspectives of safety deficiencies for an Indian city, Kolkata, and a German city, Darmstadt. The approach adopted here considers different aspects, viz., road geometry, signs and markings, traffic signal, pedestrian and non-motorized vehicle users, etc. based on a careful review of literature and road safety manuals. This helped to highlight the major safety deficiencies for a developing country. The most contrasting differences were observed in the geometric design and the traffic signal operations with a lack of consideration of needs of all types of road users in the Indian context. Finally, several recommendations were made considering the frequency of occurrence of safety deficiencies and the danger associated with them.

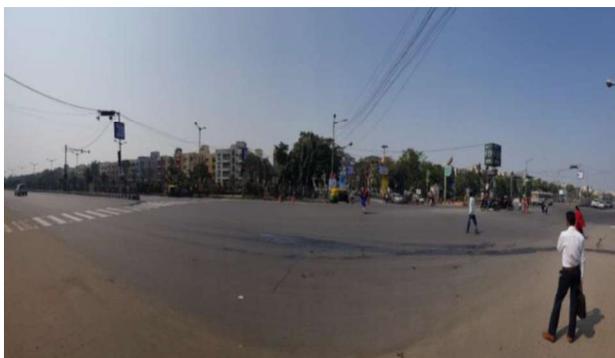
At the intersections audited in Kolkata, proper road signs (Figure 4b and 4c) and pavement markings (Figure 4a), to guide the traffic movements, were not adequately provided at every intersection observed. Such improper road signs and markings contributes significantly towards increasing the risk of crash and its severity (Islam et al., 2008; Ezeibe et al., 2019).

Figure 4. (a) Absence of road markings. (b) Improper 'No right turn' sign. (c) Improper 'No U-turn' sign. (d) Absence of proper Bus stop and shelter.

First, the provision of proper road markings has been found to improve road safety in multiple studies (Miller, 1992; Moses, 1986, Babić et al., 2020). They become especially important from the safety point of view during night when the amount of light available to the drivers reduces, thereby narrowing and shortening their field of vision and impairing their ability to perceive colour, shape, texture etc. So, it must be ensured that all intersections are provided with proper road markings for all road users including the non-motorised vehicles, in accordance with the standards (IRC: 35-1997), with proper retro-reflectivity to increase their night-time visibility. The location of stop lines were also found to be improper and too far away from the intersection approach in many cases. This resulted in stopline violations and also the need for additional time for vehicles in clearing the intersection. Therefore, stop lines should be moved near the intersection functional area to prevent violations by the motorists from stopping far beyond the stop line and to efficiently utilize the green time.

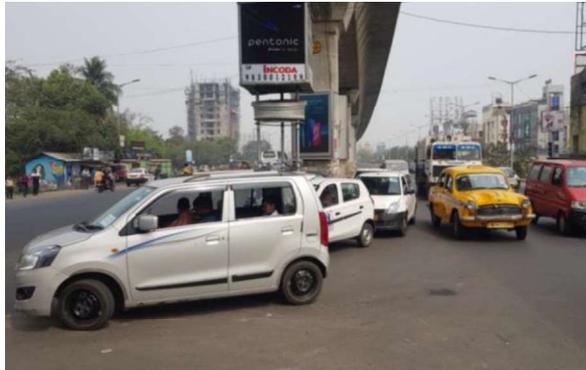
Figure 5. (a) Inadequate Right turn storage lane. (b) Absence of proper crossing facility encouraging jaywalking. (c) Absence of proper sidewalk and crossing. (d) Stop line violation by motorized vehicles. (e) Encroachment by food vendors. (f) Stop line violation by non-motorized vehicles.

Fifth, another deficiency observed in 60% intersections audited in Kolkata was the absence of enough storage lanes for the turning traffic, which was leading to congestion at the intersections. The movement of vehicles from such congested and constrained space to a more open space leads to diverging conflict which, though the least problematic of the conflict types, might eventually lead to sequential conflict. So, in order to reduce such conflicts at the intersection approaches, enough storage lanes should be provided for right and left turn traffic movements (Wang et al., 2006; Kumara et al., 2003).

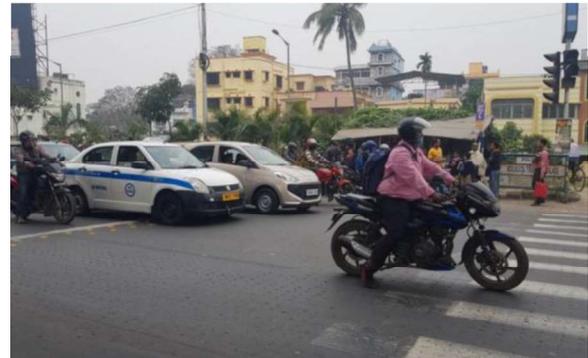
(d)

visibility at junctions. These safety deficiencies were also observed in other studies related to similar contexts (Mukherjee & Mitra, 2019; Mukherjee & Mitra, 2020). Moreover, lack of traffic discipline among road users and less strict enforcement make traffic violations (Figure 5d, 5e) a common sight.

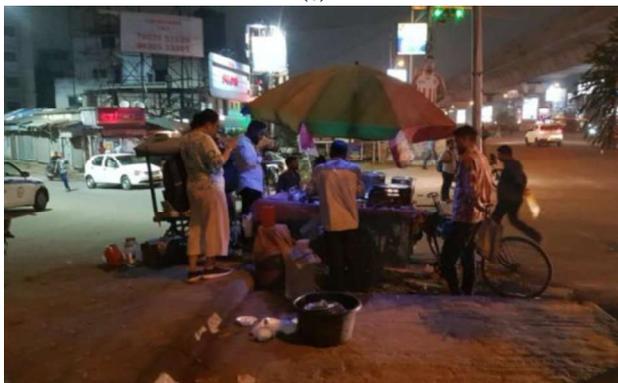
(e)

The traffic density during the peak hours was very high at all the intersections assessed in Kolkata. In addition, encroachment by roadside vendors (Figure 5e), buses and Para-transit vehicles were leading to traffic congestions at some intersections. Such encroachments, along with improper placement of billboards and road signs, obstruct the traffic signs and affect
