## EVALUATION OF THE ROADSIDE WALKWAY ENVIRONMENT OF DHAKA CITY

**Abstract:** A comfortable environment makes a journey by foot pleasant and enjoyable. However, in Dhaka city, about 60% trips are making on foot but the pedestrians are facing many problems while using the walkways. It is because; the transport planners or researchers are always emphasizing the problems of the motorized vehicles. For instance, this paper tries to explore the qualitative level of comfort of the pedestrians in Dhaka City by offering Six broad categories of roadside walking environment in terms of i) safety, ii) security, iii) convenience and comfort, iv) continuity of the walkway, v) system coherence and vi) attractiveness by some specific facilities. Qualitative data have been collected from observation survey whereas the walker's responses have been recorded through questionnaire survey from the field. By far, this study contributes the factors that are very important to assess the roadside walking environment in a developing country's city with some attributes.

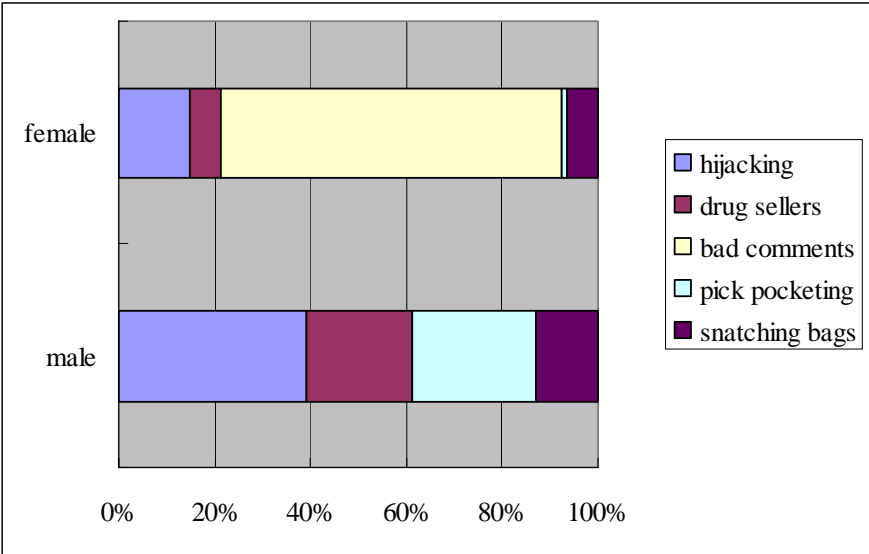
Figure 2, Types of social securities and walker’s responses.

From the figure2, it can be seen that about 40% male walkers complained about hijacking and about 80% women walkers complained about throwing bad comments. But both male and female walkers concern goes to hijacking as this is one of the headaches in Dhaka city

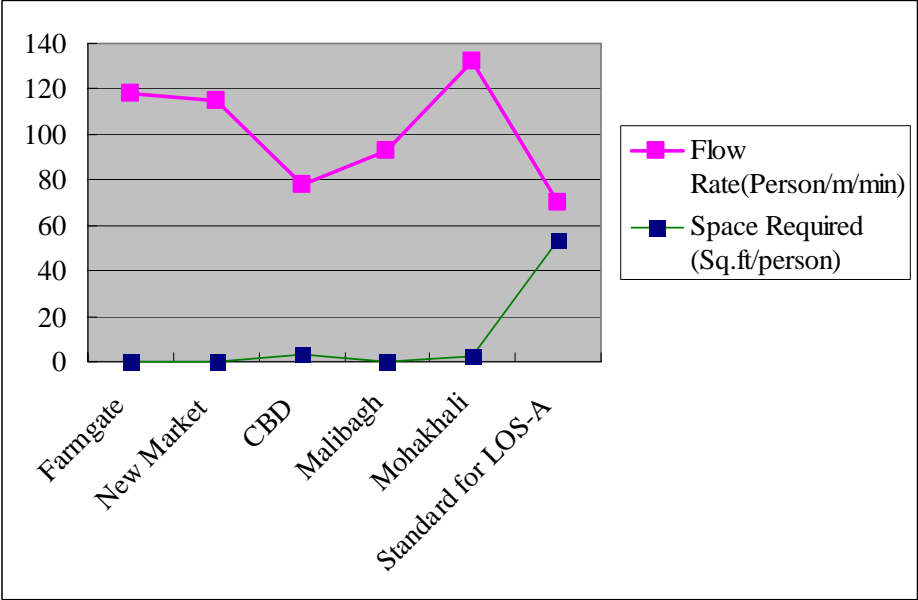
Figure 3. Pedestrian Flow in compare with the standard level ‘A’

Figure 3 depicted the existing pedestrian flow rate and density in Dhaka City in compare to the standard level given in some books and literatures. However, figure 4 depicts the existing condition with the standard F level of service in a scale of A to F. These two situations compare the standard level of services with the condition of Dhaka City. However, Figure 3 is an output in the peak hour situation and figure 4 is an output of the off peak hour survey. For this instance, we can easily see that the F level can be found in the off peak hours when comparatively lower numbers of pedestrians are using walkway.

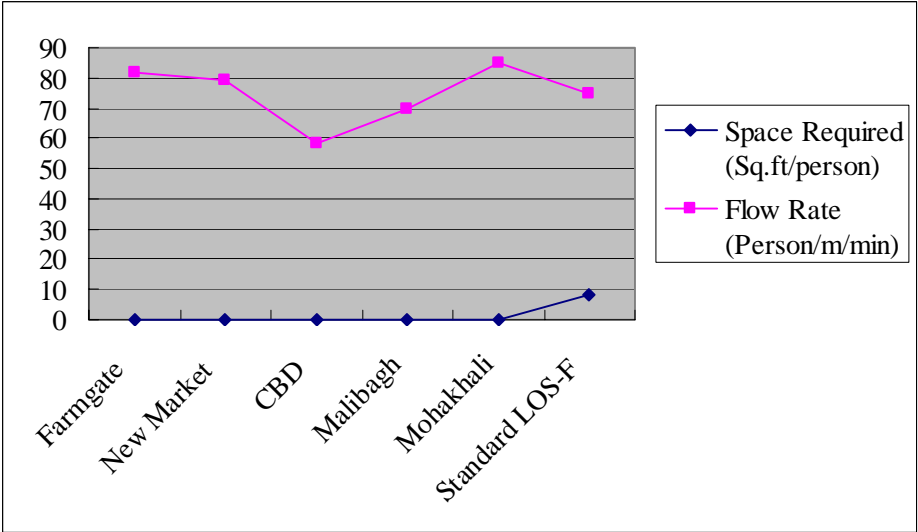
Figure 4. Pedestrian Flow in compare with the standard level ‘F’

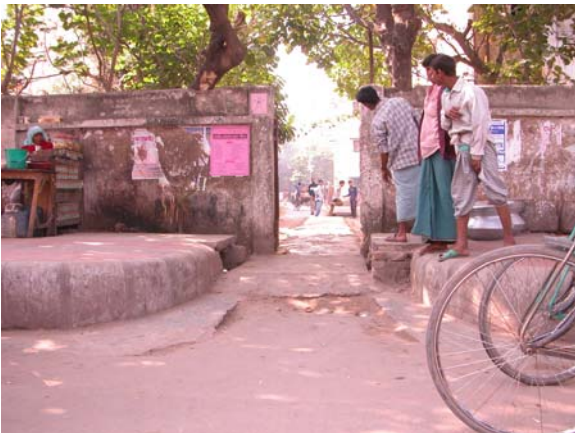
Figure 5. Discontinuity of Sidewalks for allowing access to local housing

Figure 5 shows that the walkway got disrupted for allowing a narrow access to a housing area.

The height of the sidewalk is 1 foot and 6 inches. It is very difficult even for a young man to get down and walk on the way while walking. Smooth landing could be provided without any major efforts. However, figure 6 has been taken from the Farmgate area where this small access connecting with another road. Older person like the picture can not feel comfortable with this discontinuity of the sidewalks as well.

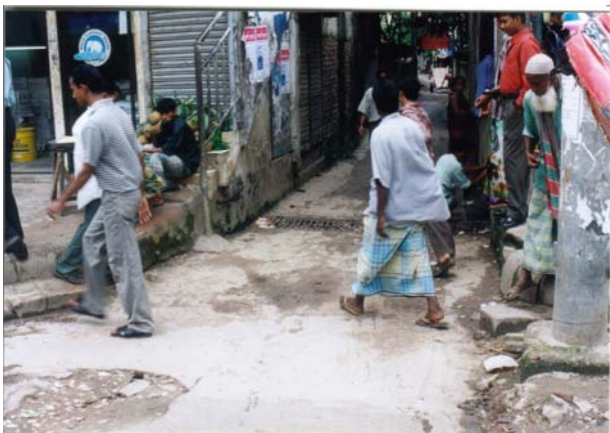
Figure 6. Discontinuity of walkway for giving access to other roads

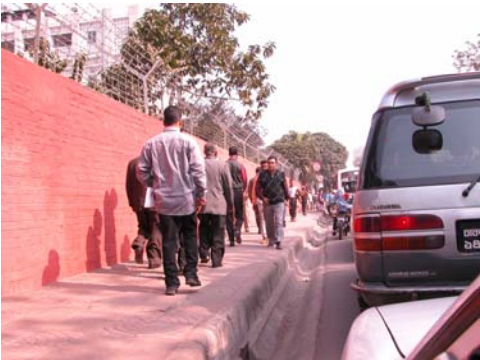
Figure 7. Rigid wall at the left side of walkway is a bad design criterion

Pictures placed in above show two different types of wall that have been placed beside the walkway. Figure 7 shows a very rigid wall that hinders the visibility of the walkers. For this instance, walkers can not understand the presence of other service activities beside the walkway. However, in the figure 8, visibility of an important office can be seen by the walkers while they

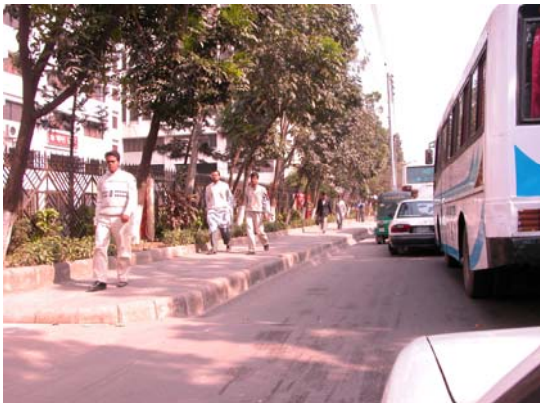
Figure 8. Flexible wall at the left side of walkway is a good design criterion

are walking along the road the side. In the New Market area, sidewalks are not well connected with the shopping centers whereas in the CBD area, very narrow sidewalks connect with some big office buildings. In the Mohakhali transit area; there is poor connectivity of the footpaths for the transit passengers to change their route of transport modes. In this block, pedestrian overpass is needed urgently to connect the transit passengers (Sowgat & Khan, 2002).

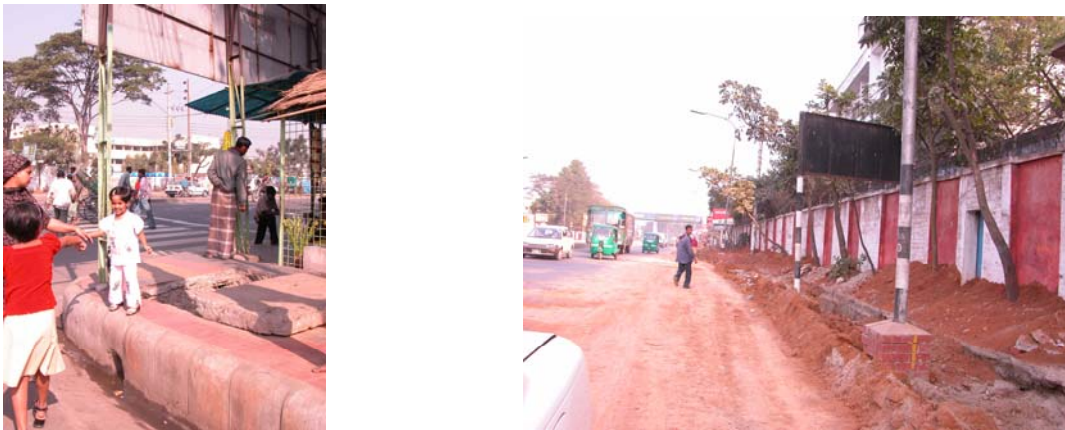
Figure 9 (a, b). Problems with scales in designing sidewalks in Dhaka City.

poorly to make the harmony with the streets. In the left picture, the height of the walkway is 2 feet that makes very difficult situation for the vulnerable walkers like the baby. In the right hand picture it can be seen that a big major road has only a 3 feet width sidewalk full with mud. For instance, walkers do not want to use the footpaths for walking rather using the carriage way which allow more pedestrian accidents as well.

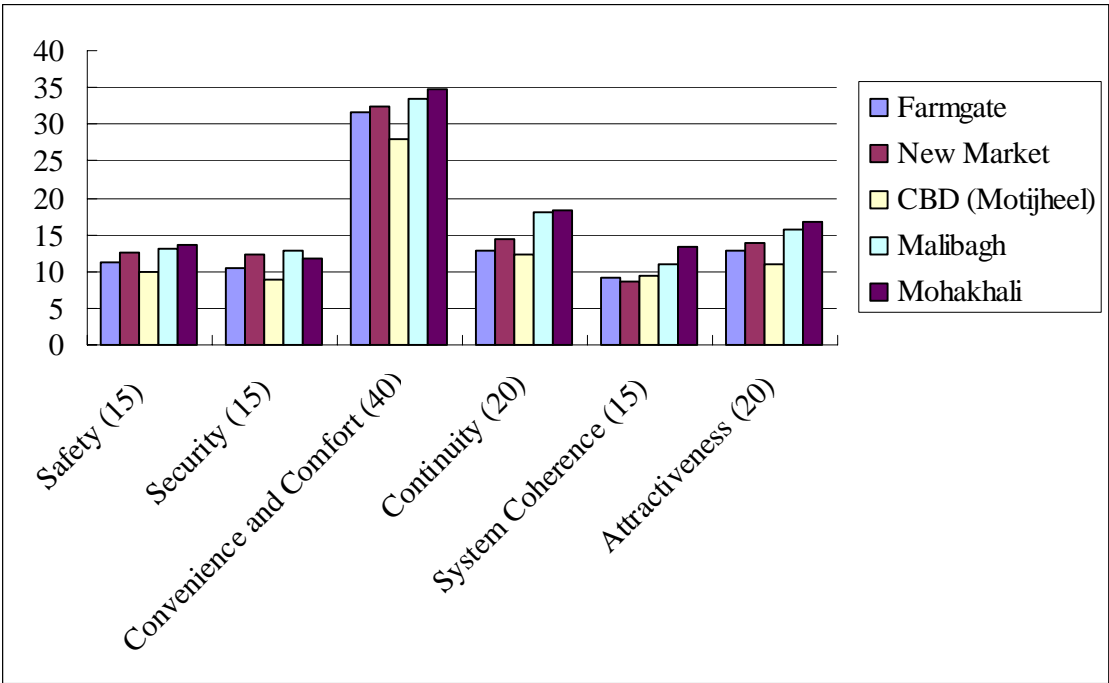
Figure 10. Summarized responses of the pedestrians with the 6 prescribed criteria. In the above figure, the 6 prescribed criteria have been placed and it also depicts the standing of some 5 studied areas. We distributed 500 questionnaires to the pedestrians in 5 areas to give their impressions in 6 specific criteria and sub-criteria. We followed itemized data collection method (Urban Transportation Planning, 2nd Edition, Meyer, Miller) at a scale 1 to 5. In the figure 10, safety, security and system coherence was measured based on 3 sub criteria, whereas continuity and attractiveness were measured with 4 sub-criteria. Convenience and comfort was measured based on 8 criteria. However, the lowest the value in each area means the highest walkway environment and the highest the number mean the bad walkway environment in Dhaka city. For example, safety can be very good if the value goes to 3 and the worst case would be 15. From the figure 10, it can be seen that among 5 different areas, safety is very poor in Mohakhali area in compare to CBD (Motijheel) area.
