Development of Recessed Pavement Markings That Incorporate Rumble Strips

Abstract: In winter in Hokkaido, pavement markings are damaged from snow removal, and every spring, the markings need to be reapplied. The authors propose a system of pavement markings whose recessed design prevents scraping damage from snowplows and whose incorporation of rumble strips increases driving safety. To determine the optimum design for recessed pavement markings, trial installation used two intervals between grooves. Driving tests found that recessed markings with long intervals generate more noise and vibration than recessed markings with short intervals, making the former more noticeable than the latter. It was found that waterborne paints are not durable enough to be used on recessed pavement markings. Spraying of thermoplastic paints were chosen instead. Furthermore, in order to improve of nighttime visibility under rainy conditions by highly reflective beads were used. This paper reports on development of recessed pavement markings that incorporate rumble strips.

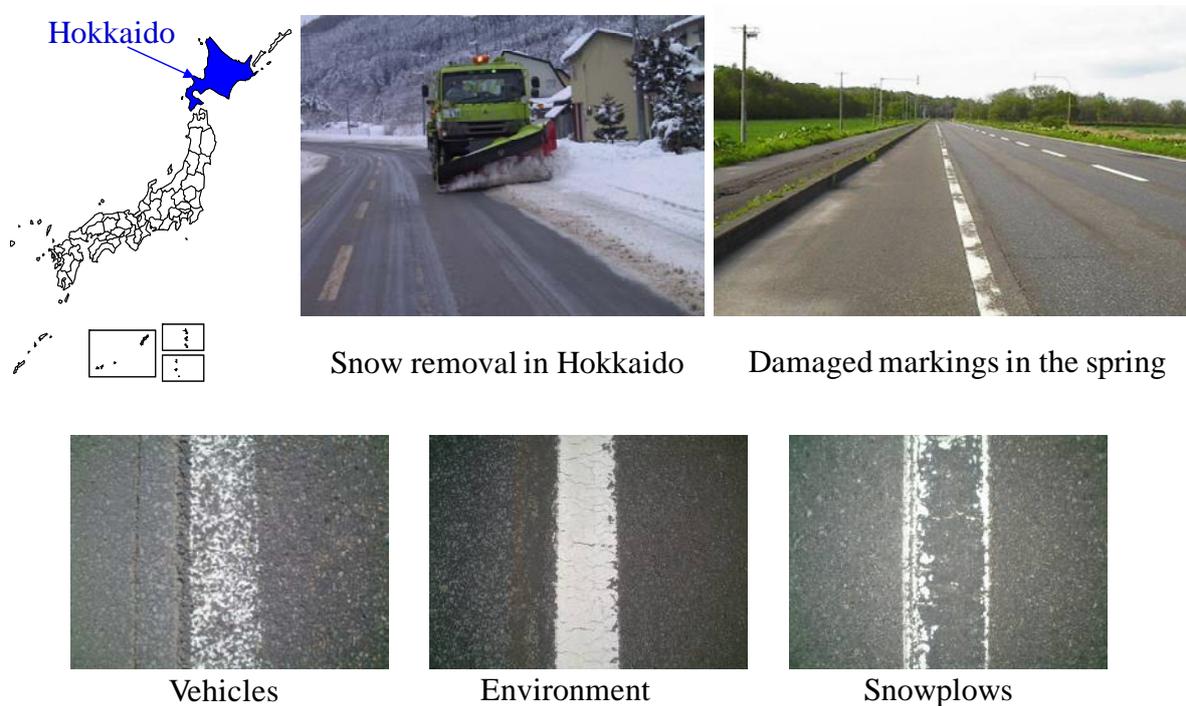
Factors in pavement marking damage
 Figure 1 Damaged markings in Hokkaido

In winter in Hokkaido, northern Japan, pavement markings are damaged from scraping by snowplows and tire chains, and every spring, the markings need to be reapplied. Thermoplastic paints are the standard in Japan. In Hokkaido, thermoplastic markings are often scraped by the blades of snowplows (Figure 1). For this reason, the lowest-priced waterborne paints have mostly been used. Moreover, the cost of such maintenance is particularly onerous in light of current constraints on road budgets in Japan.

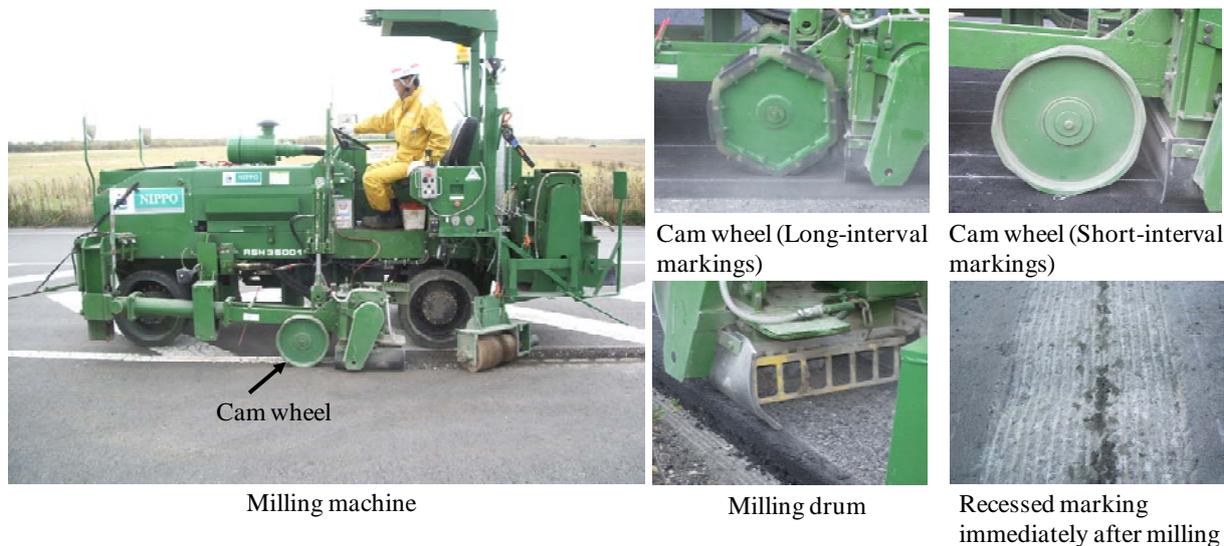
Figure 2 Installation of recessed pavement markings

A milling machine is used to cut the longitudinal recess for the markings while simultaneously cutting the transverse grooves for the rumble strips. The milling drum is mounted at the rear left of the milling machine, making it convenient for use even on narrow road shoulders.

In the proposed pavement marking system, the longitudinal recess is shallow, and it is important to maintain a constant depth for that recess. Also, because the rumble strips are milled into the recess, they are shallower than conventional rumble strips. The most important factor in milling grooves of a consistent depth is the precision of the cam wheels.

The proposed pavement marking system is to be installed at the road shoulder. It should not adversely affect the stability of bicycles and motorbikes. To produce shallow grooves for minimum bumpiness, the vertical movement of the milling drum needs to be small. Therefore, the cam wheel is closer to round than it would be for deeper rumble strips. In this study, two types of cam wheels were tested (Figure 2). The two types produce longitudinal recesses and transverse grooves with the same transverse width, but one produces the grooves at long intervals and the other produces them at short intervals. Figure 3 shows the dimensions of the cam wheels, the upper surface of recessed pavement markings that incorporate rumble strips and a longitudinal section of those markings.

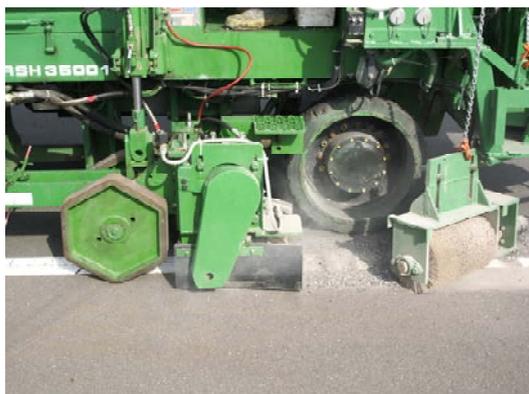
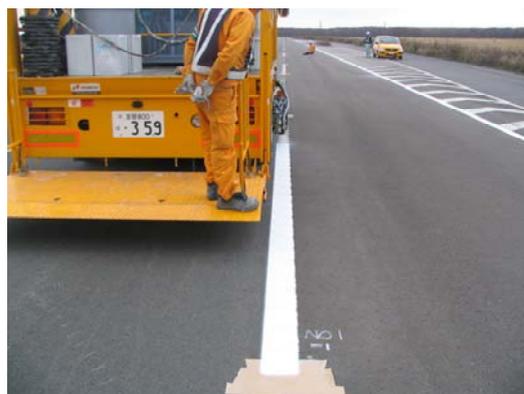
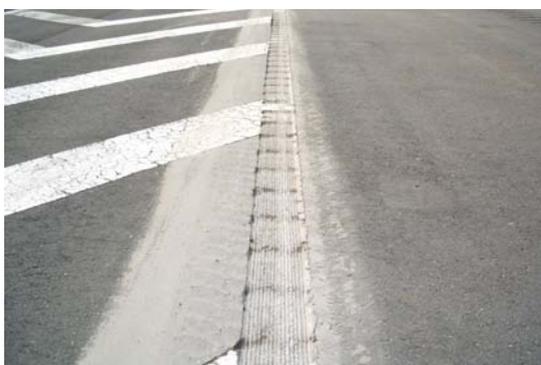
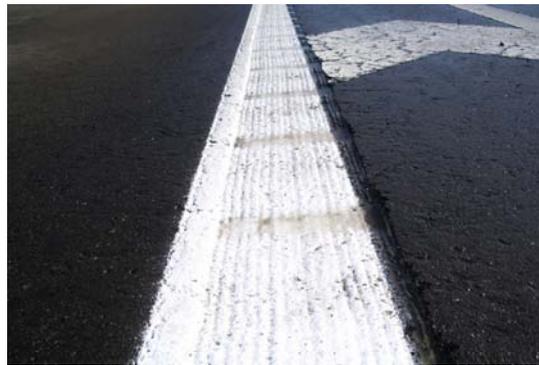
Figure 4 Newly milled recessed pavement markings

Installation of recessed pavement markings

Pavement marking paint spraying

Immediately after milling

Immediately after marking paint spraying

Figure 4 shows the recessed pavement markings after milling and immediately after pavement marking paint application. As shown in the photo, the milling drum cuts a shallow longitudinal recess. This tends to trap asphalt chippings from the milling process. These chippings have to be thoroughly removed, since the marking paint is sprayed directly into this recess.

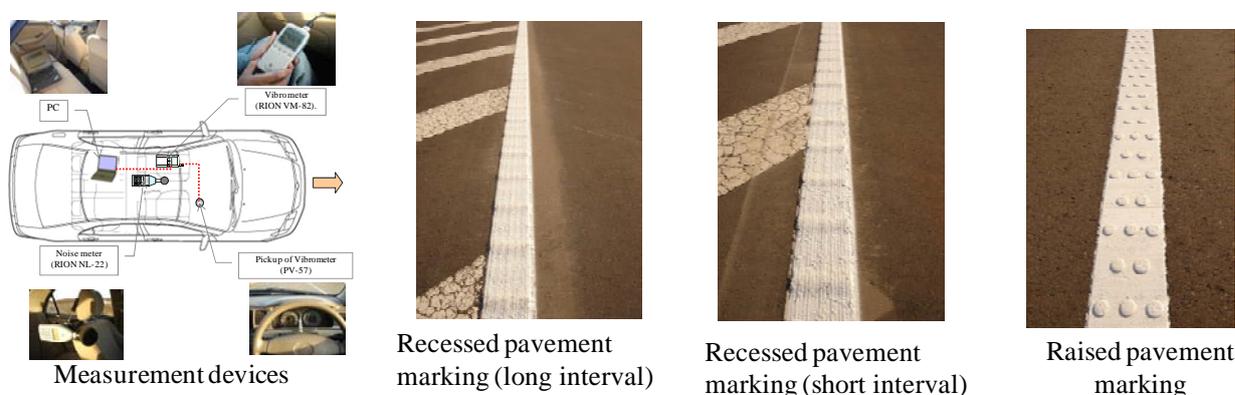
Figure 5 Measurements of noise and vibration inside the car

Noise and vibration caused by travel over the rumble strips in the recessed pavement markings were studied using a noise meter (RION NL-22) and vibrometer (RION VM-82). Raised pavement markings were installed for comparison of noise and vibration with the recessed pavement markings. Noise and vibration were measured by installing instruments in a sedan car (1500 cc engine, 185/70R14 tire size) and driving it over the recessed pavement markings and the raised pavement markings. The microphone of the noise meter was installed on the passenger seat headrest, and the vibrometer was installed on the steering column (Figure 5). Noise was measured at travel speeds of 40, 60, 80 and 100 km/h, three times for each speed. The noise was the average of the maximum value for each of the three travels (Figure 6). The long-interval recessed pavement marking produced the most noise, which was roughly the same at all speeds. The noises produced by the long-interval recessed pavement marking were often greater than those of raised pavement markings, and they were about 8 to 16 dB greater than those for normal pavement.

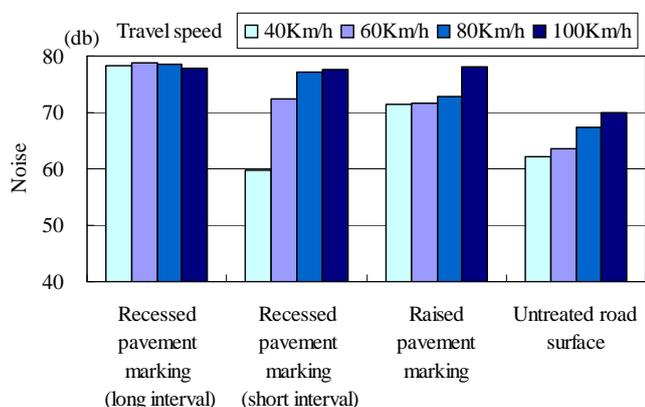
Figure 6 Noise inside the car

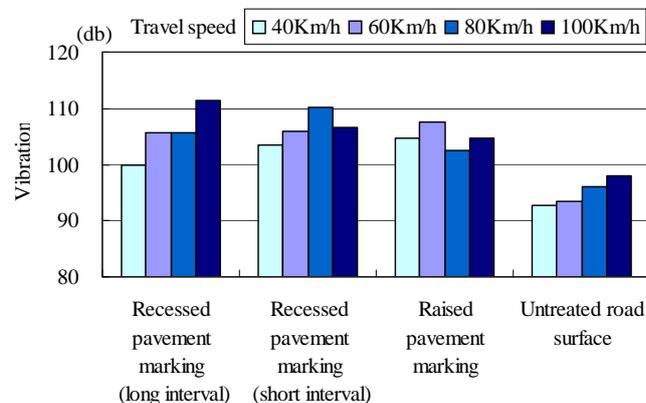
Figure 7 Vibration inside the car

Vibration inside the car was measured in accordance with the JIS method for measuring vibration that changes cyclically and/or intermittently, and the measured vibration per travel was the average of the ten highest values for that travel. The vibration for each travel speed was obtained by averaging the ten greatest vibration values for each of the three travels (Figure 7). Measured vibration did not differ greatly among the long-interval recessed pavement markings, short-interval recessed pavement markings, and raised pavement markings. However, the vibration produced by the three types of markings was greater than that produced by normal asphalt pavement.

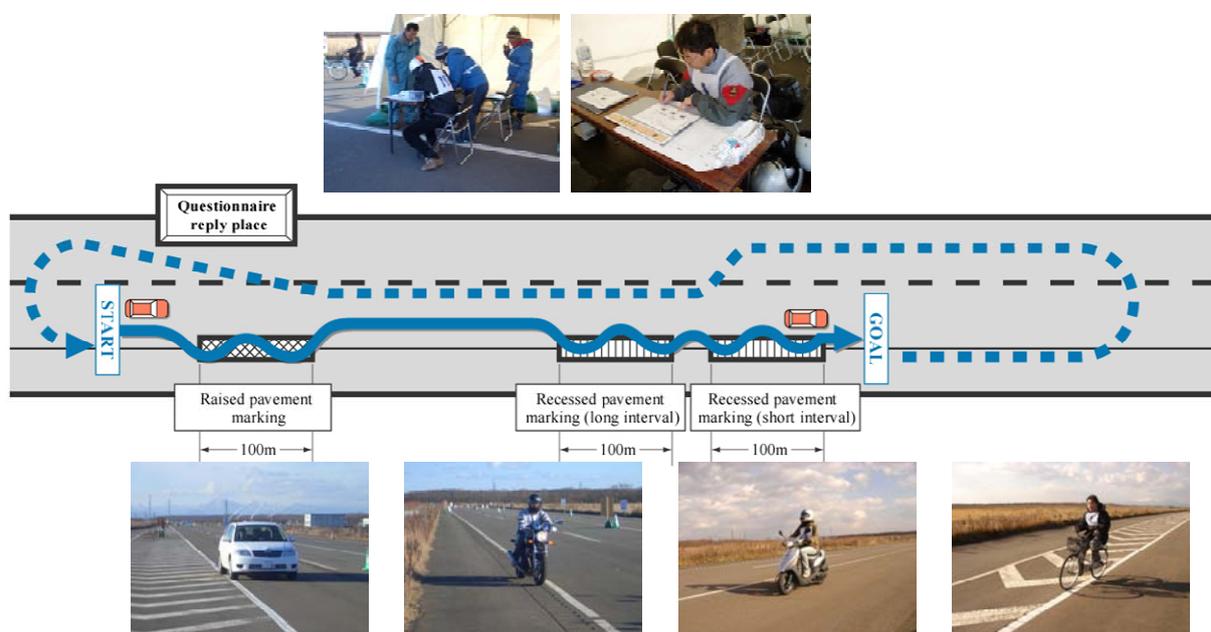
Figure 8 Running test

The tests were performed for the seven days from November 26, 2005, by a panel of 104 subjects driving a sedan car (1500 cc), a large motorcycle (400 cc), a small motorcycle (< 50 cc), and a bicycle. The questionnaire survey was performed after each driver tested road sections installed with long-interval recessed pavement markings, short-interval recessed pavement markings and raised pavement markings (Figure 8).

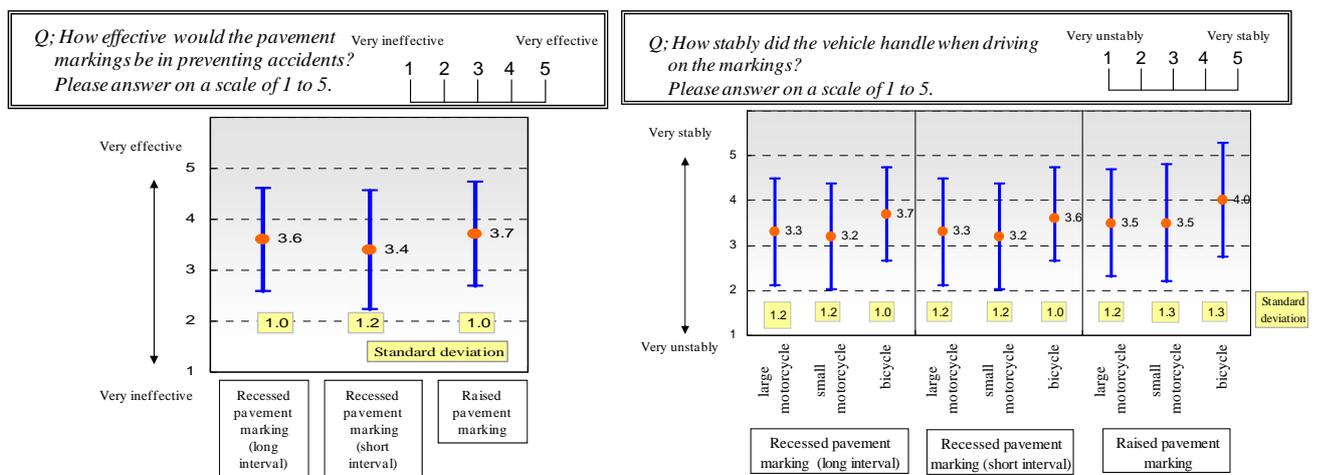
(a) Avg. responses of car drivers (b) Avg. response for drivers of other vehicles

Figure 9 Accident prevention effectiveness and handling stability

the questionnaire, the test drivers were asked to score the effectiveness of each marking in preventing accidents by generating noise and vibration to alert drivers' on a scale from 1 (Very ineffective) to 5 (Very effective). They were also asked to score how stably the large motorcycle, small motorcycle and bicycle handled on the markings, on a scale from 1 (Very unstably) to 5 (Very stably). Figure 9 shows average scores of respondents and standard deviation of each test run.

For effectiveness in preventing car accidents, the long-interval recessed pavement markings had a slightly higher average rating than the short-interval recessed pavement markings: The average score was 3.6 for the former (standard deviation of 1.0) and 3.4 for the latter (standard deviation of 1.2). These were similar to the average score for the raised pavement marking.

For handling stability reported by large and small motorcyclists, the long-interval recessed pavement markings had the same average score as the short-interval markings: The average handling stability score was 3.3 (standard deviation of 1.2) for both markings. For handling

stability reported by cyclists, the long-interval recessed pavement markings had roughly the same average score as the short-interval markings: The average handling stability score was 3.7 for the long-interval recessed pavement markings (standard deviation: 1.0) and 3.6 for the short-interval recessed pavement markings (standard deviation: 1.0). The handling stability scores reported by cyclists for the long- and short-interval recessed pavement markings did not differ greatly from those reported by cyclists for the raised pavement marking.

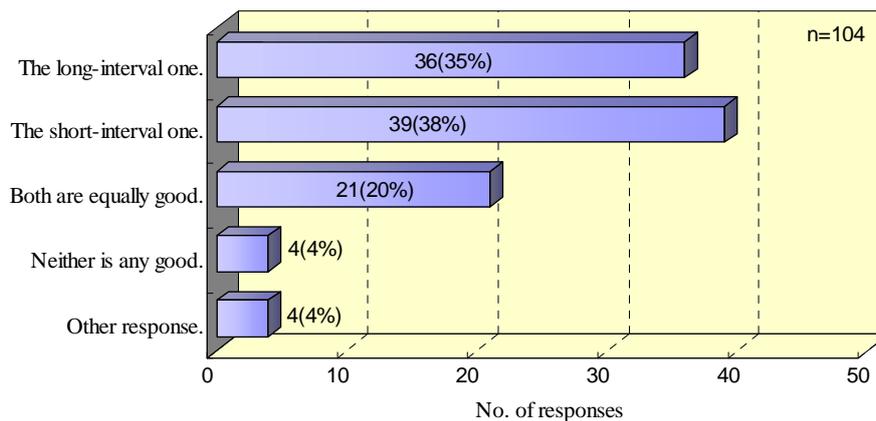
Figure 10 Which is the better of the two recessed pavement markings?

At the end of the questionnaire, the test drivers were asked “Which is the better of the two recessed pavement markings?” (Figure 10). Thirty-eight percent answered “The short-interval one,” and 35% answered “The long-interval one.” Only 4.4% answered, “Neither is any good.” Road users indicated their support for installation of recessed pavement markings that incorporate rumble strips.

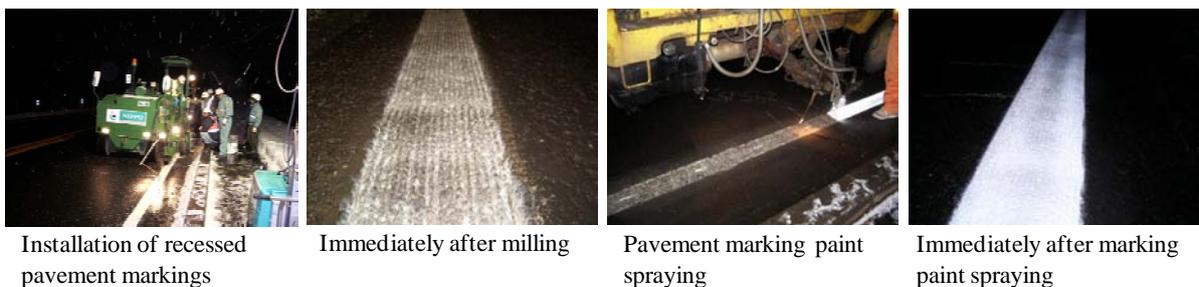
Figure 11 Test installations at Sapporo City, on National Highway 230

To test the durability of the recessed pavement markings, test installations were performed in the Jozankei district of Minami Ward, Sapporo City, on National Highway 230 (Figure 11). The marking was installed at the shoulder on 10 m of straightaway and 10 m of curves. The recessed pavement markings for the test were the long-interval type. The test installation was performed late at night on November 24, 2005. Since the temperature dropped below 5°C, a solvent-based marking paint was used, and it was heated for spraying.

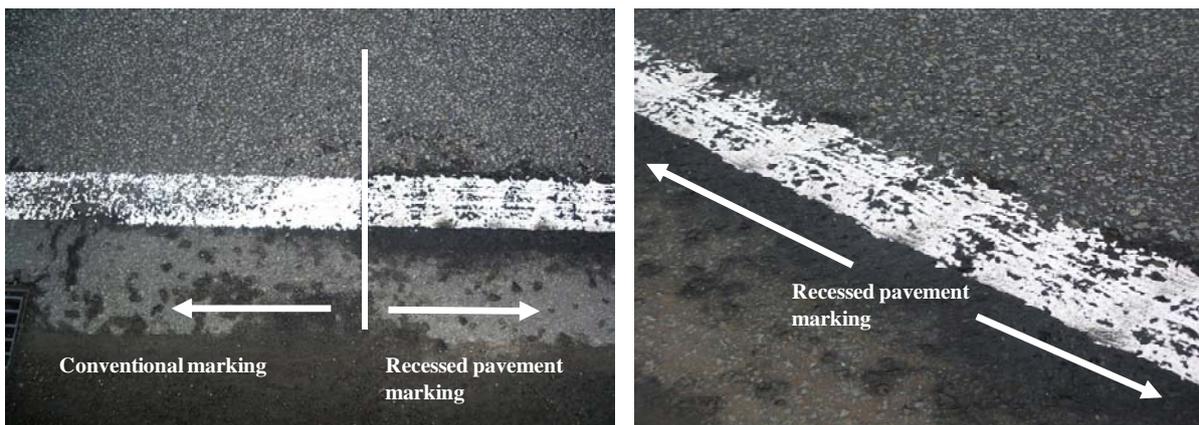
Figure 12 Conventional and recessed pavement markings (Rte. 230, 04/13/06)

Figure 12 shows a conventional pavement marking and a recessed pavement marking as of April 13, 2006 (i.e., after 19 weeks in service). The photo shows that the marking paint for the recessed pavement marking does not differ in durability from that for conventional pavement markings. The marking paint has spalled for both, although for the recessed marking the spalling is from small longitudinal grooves left by the milling machine. The paint at the spalled portions was brittle, and some portions could be removed by hand. Spalling of paint was also observed at the test installations on the Tomakomai Winter Test Track. The failure of the paint to adhere to the asphalt was attributed to inadequate flow into the small grooves. As a result, the pavement markings seem to have been partially damaged or spalled by wheel loadings. When the marking application method is spraying with waterborne or solvent-based paints, recessed pavement markings are not as durable as conventional surface markings (Figure 13).

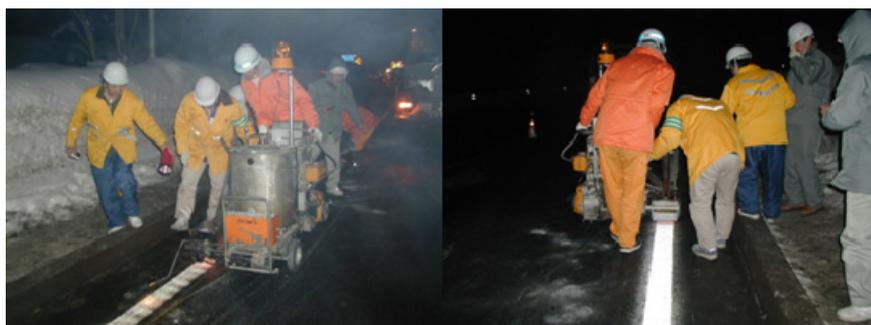
Figure 16 Application of thermoplastic paint to National Highway 230 (March 19, 2007)

To verify the durability of recessed pavement markings consisting of thermoplastic paint, markings already created in a 2005 experiment in the Jozankei district of Sapporo City's Minami Ward along National Highway 230 were reapplied by spraying over sections of 10 m each. The test applications were conducted during the night on March 19, 2007 (Figure 16). Figure 17 shows the pavement markings after winter on May 16, 2008. Compared with standard pavement markings that use waterborne paint, the sections of recessed pavement marking remained more clearly visible and were without damage. Accordingly, the application of thermoplastic paint is expected to further improve durability.

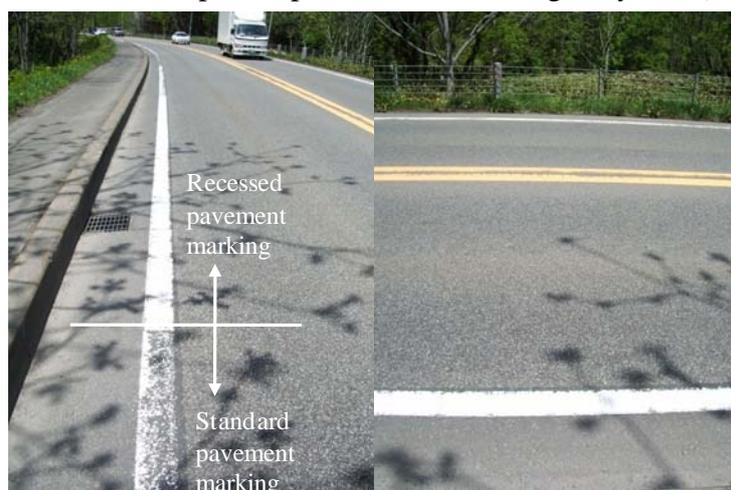
Figure 17 Recessed pavement marking observed on May 16, 2008

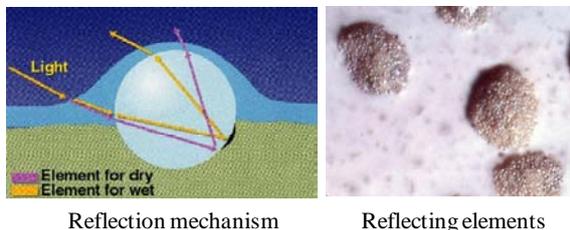
Figure 18 Improvement of nighttime visibility under rainy conditions by highly reflective beads

One potential disadvantage of recessed pavement markings (i.e., those located lower than the pavement surface) is decreased visibility when roads are wet in rainy nighttime conditions. Since the visibility of standard pavement markings also deteriorates in such conditions, there is concern that recessed pavement markings might show an even larger decrease in visibility. For this reason, high-refractive-index glass beads that improve visibility in rainy nighttime conditions were tested to ascertain their effects. High-refractive-index glass beads are a pavement marking material that provides improved reflective performance in wet conditions (Figure 18). They are produced by coating the surface of sand granules larger than standard-size glass beads with fine glass beads to achieve their characteristic high refractive index (Figure 19).

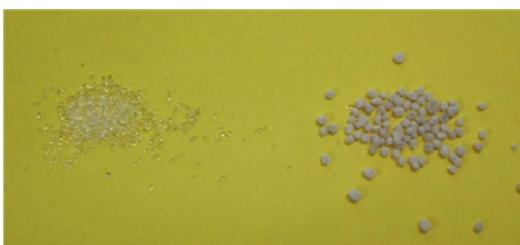
Figure 19 Standard glass beads (left) and high-refractive-index glass beads (right)

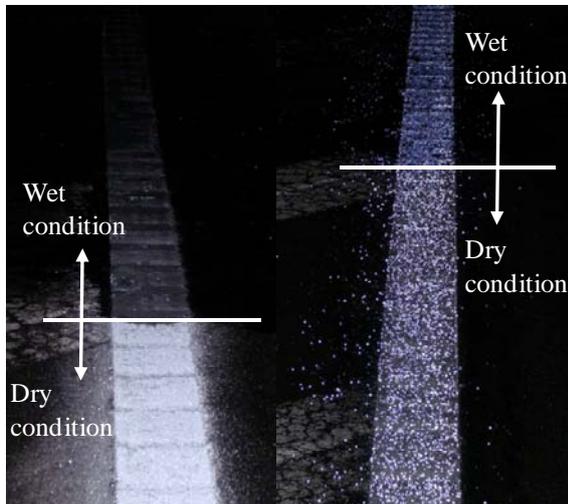
Figure 20 Standard thermoplastic paint (left) and thermoplastic paint with high-refractive-index glass beads (right)

Thermoplastic paint containing standard glass beads and the same paint containing high-refractive-index glass beads were each applied to a recessed pavement marking over sections of 100 m on the Tomakomai Winter Test Track. When wet road surface conditions were created by spraying water on each section at night, visibility was clearly better for the section with high-refractive-index glass beads than for that with standard glass beads (Figure 20).

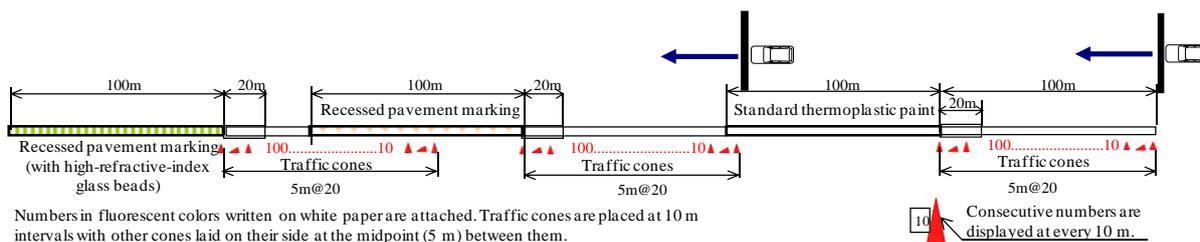
Numbers in fluorescent colors written on white paper are attached. Traffic cones are placed at 10 m intervals with other cones laid on their side at the midpoint (5 m) between them. Consecutive numbers are displayed at every 10 m.

Figure 21 Outline of visibility evaluation testing involving general road users

To enable the quantitative evaluation of visibility in rainy nighttime conditions, a driving test was conducted on November 26, 2007 at the Tomakomai Winter Test Track with research participants consisting of 52 general road users chosen from among members of the public. In terms of testing conditions, the experiment was carried out on a cloudy night, and water was regularly sprayed using a road sprinkler to produce a wet road surface. The test vehicle was a passenger car, and research participants drove at a speed of approximately 20 km/h along the test course, which had no lighting, with the headlights set to low beam. At the point where the start of the recessed pavement markings came into sight, research participants gave a signal to a member of the testing staff who was also on board, who then identified the location from traffic cones placed at intervals of 5 m along the roadside and regarded the resulting value as the visible range. The visible range indicates how far into the distance a pavement marking can be seen. In this test, a black board was placed in front of each pavement marking, and the distance from which research participants could see them was measured. The location at which the pavement markings came into sight was used to judge the extent of the pavement markings that research participants could see. For comparison, a non-recessed pavement marking consisting of regular thermoplastic paint was also tested to evaluate its visibility (Figure 21).

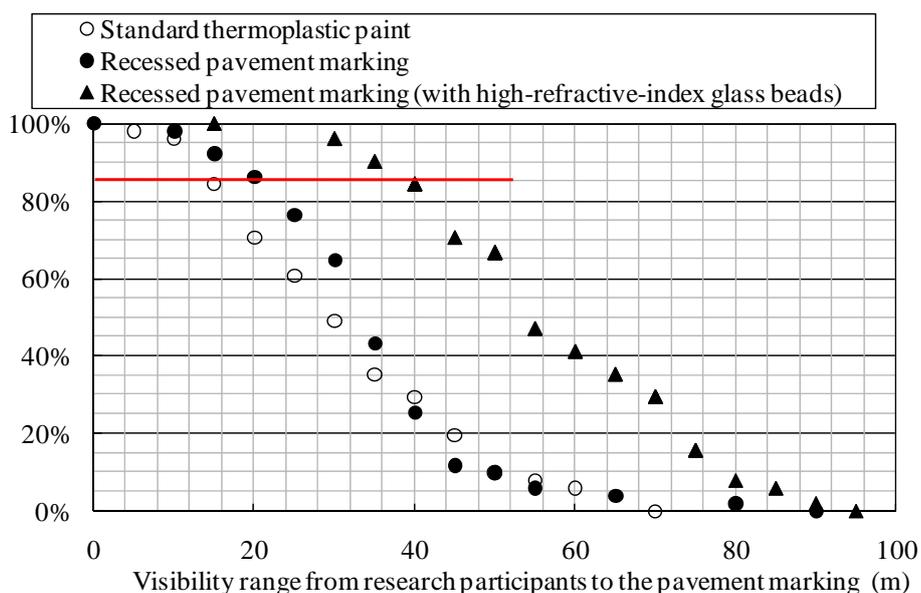
Figure 22 Cumulative frequency distribution of visible range

In terms of the cumulative frequency distribution of the visibility range, 85% of research participants were able to visually confirm the standard pavement marking 15 m ahead, the recessed pavement marking 20 m ahead and the recessed pavement marking with high-refractive-index glass beads 40 m ahead (Figure 22).

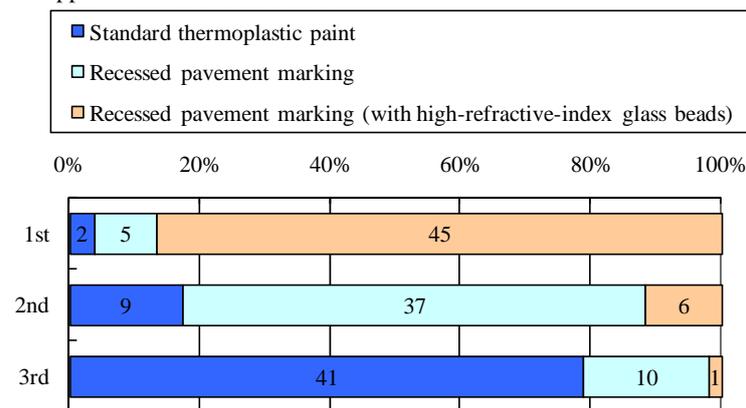
Figure 23 Preferred pavement marking type for application to roads in service

To verify the acceptability of recessed pavement markings by general road users, a questionnaire survey was conducted among research participants after the visibility evaluation test. On the questionnaire, the characteristics of each pavement marking type, including estimated application costs and service life, were listed as shown in Table 2. In response to a question about application to roads in service, most subjects selected recessed pavement markings with high-refractive-index glass beads – despite their high application costs – as the preferred pavement marking type (Figure 23). In response to a question about the application

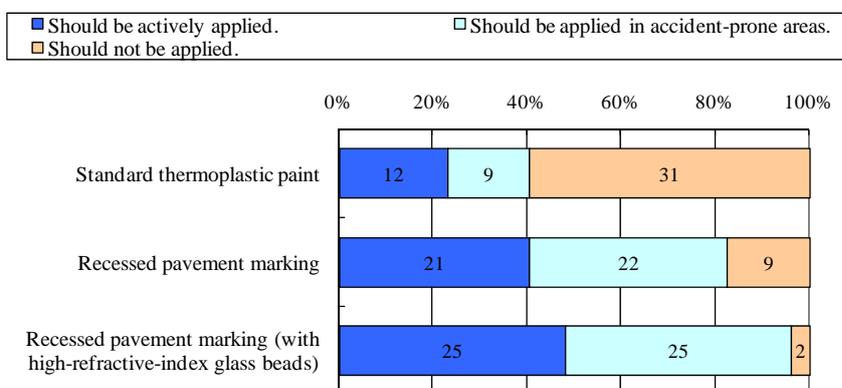
Figure 24 Acceptability of each pavement marking type

of recessed pavement markings and recessed pavement markings with high-refractive-index glass beads, 43 subjects (83%) and 50 subjects (96%), respectively, selected either “Should be actively applied” or “Should be applied in accident-prone areas,” showing that the majority of subjects had a positive opinion on the application of these two types (Figure 24).
