## Case Study of Pedestrian Risk Behavior and Survival Analysis

**Abstract:** In order to improve traffic flow, signal-free, grade-separated intersections in Delhi have often replaced signalized intersections. Evaluating the impact of signal free intersections on pedestrians is important when nearly fifty percent fatalities in the city involve pedestrians. Examining a pedestrian sample before and after site reconstruction produces a better understanding of the subsequent changes in pedestrian risk behavior.

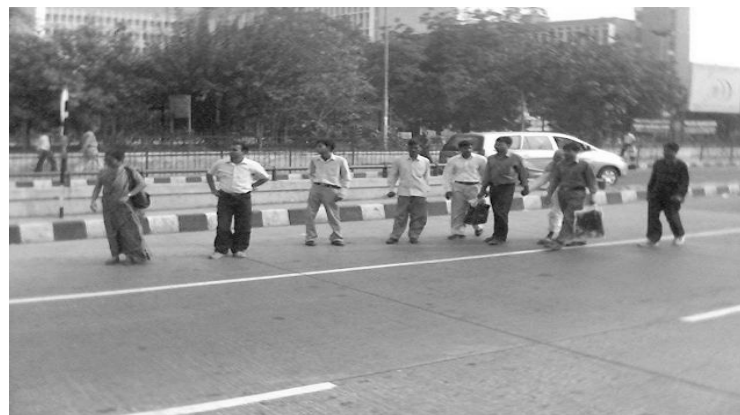
Pedestrians crossing the road at AIIMS after reconstruction

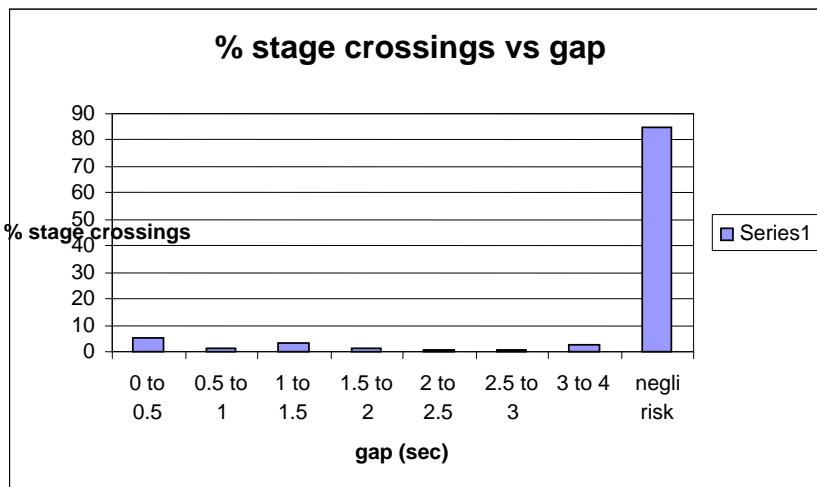
Figure 5 Accepted gaps before reconstruction

Figure 5 shows the percentage of all stage crossings versus accepted gap. When the accepted gap is more than four seconds, risk to the pedestrian becomes negligible. Figure 5 shows the percentage of stage crossings versus accepted gap before reconstruction. It includes all unprotected pedestrian crossings for all stages whether full or half. Only 15 percent of the stage crossings had a risk, i.e., accepted gaps less than or equal to four seconds. The remaining 85 percent had negligible risk. Figure 6 shows the percentage of stage crossings versus accepted gap after reconstruction. It includes all unprotected stage crossings that pedestrians completed. Only 38 percent had negligible risk. In Figure 6, risk has increased after reconstruction; more than 35 percent of stage crossings had accepted gaps less than one second as compared to 6 percent of stage crossings before reconstruction.

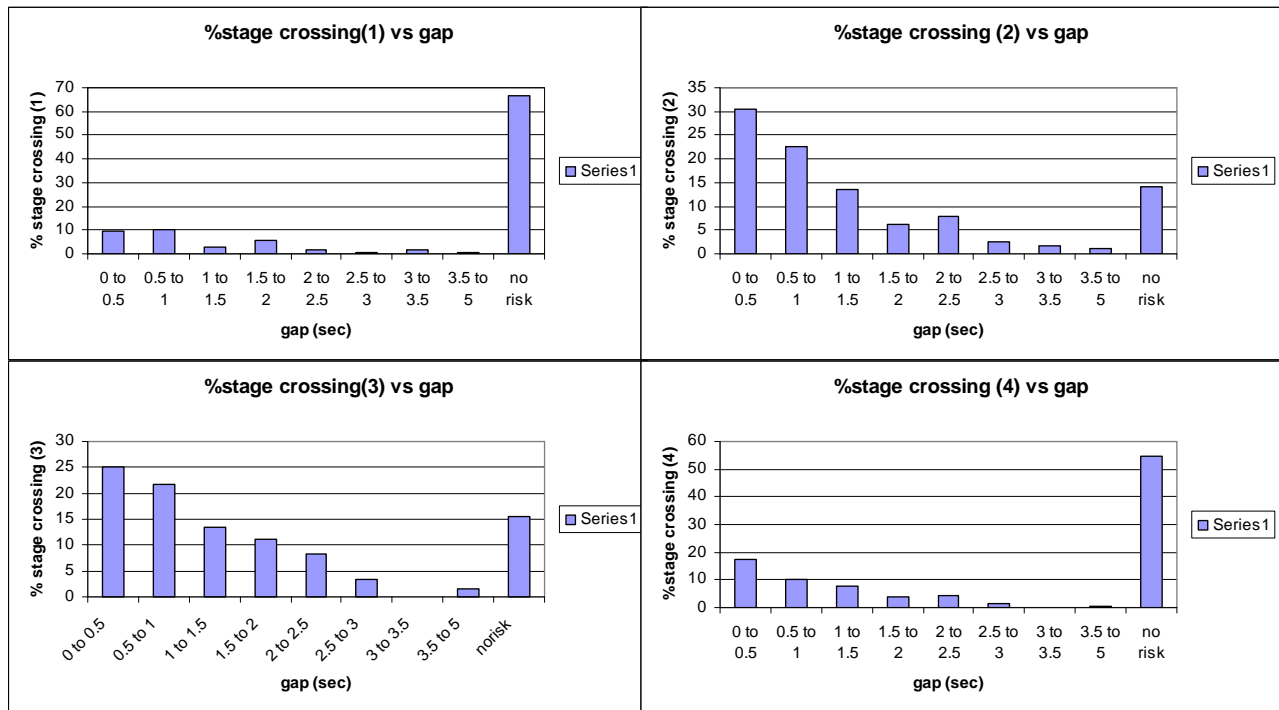
Figure 7. Accepted Gaps by Stage after Reconstruction

From Figure 7 we see a greater percentage of pedestrians had exposure to higher risk, i.e., accepted gaps less than one second while pedestrians are in Stage 2 and Stage 3 crossings than Stage 1 and Stage 4 crossings. In Stage 1 and Stage 4, a very large number of pedestrians are facing negligible

risk while this percentage is low in Stage 2 and Stage 3. Stage 2 and Stage 3 involve more approaching cars and other fast approaching motorized traffic.
